Flood Damages and Mitigation Options Assessment Report

Upper Mt. Emu Creek Flood Investigation

Glenelg Hopkins CMA

17 June 2020

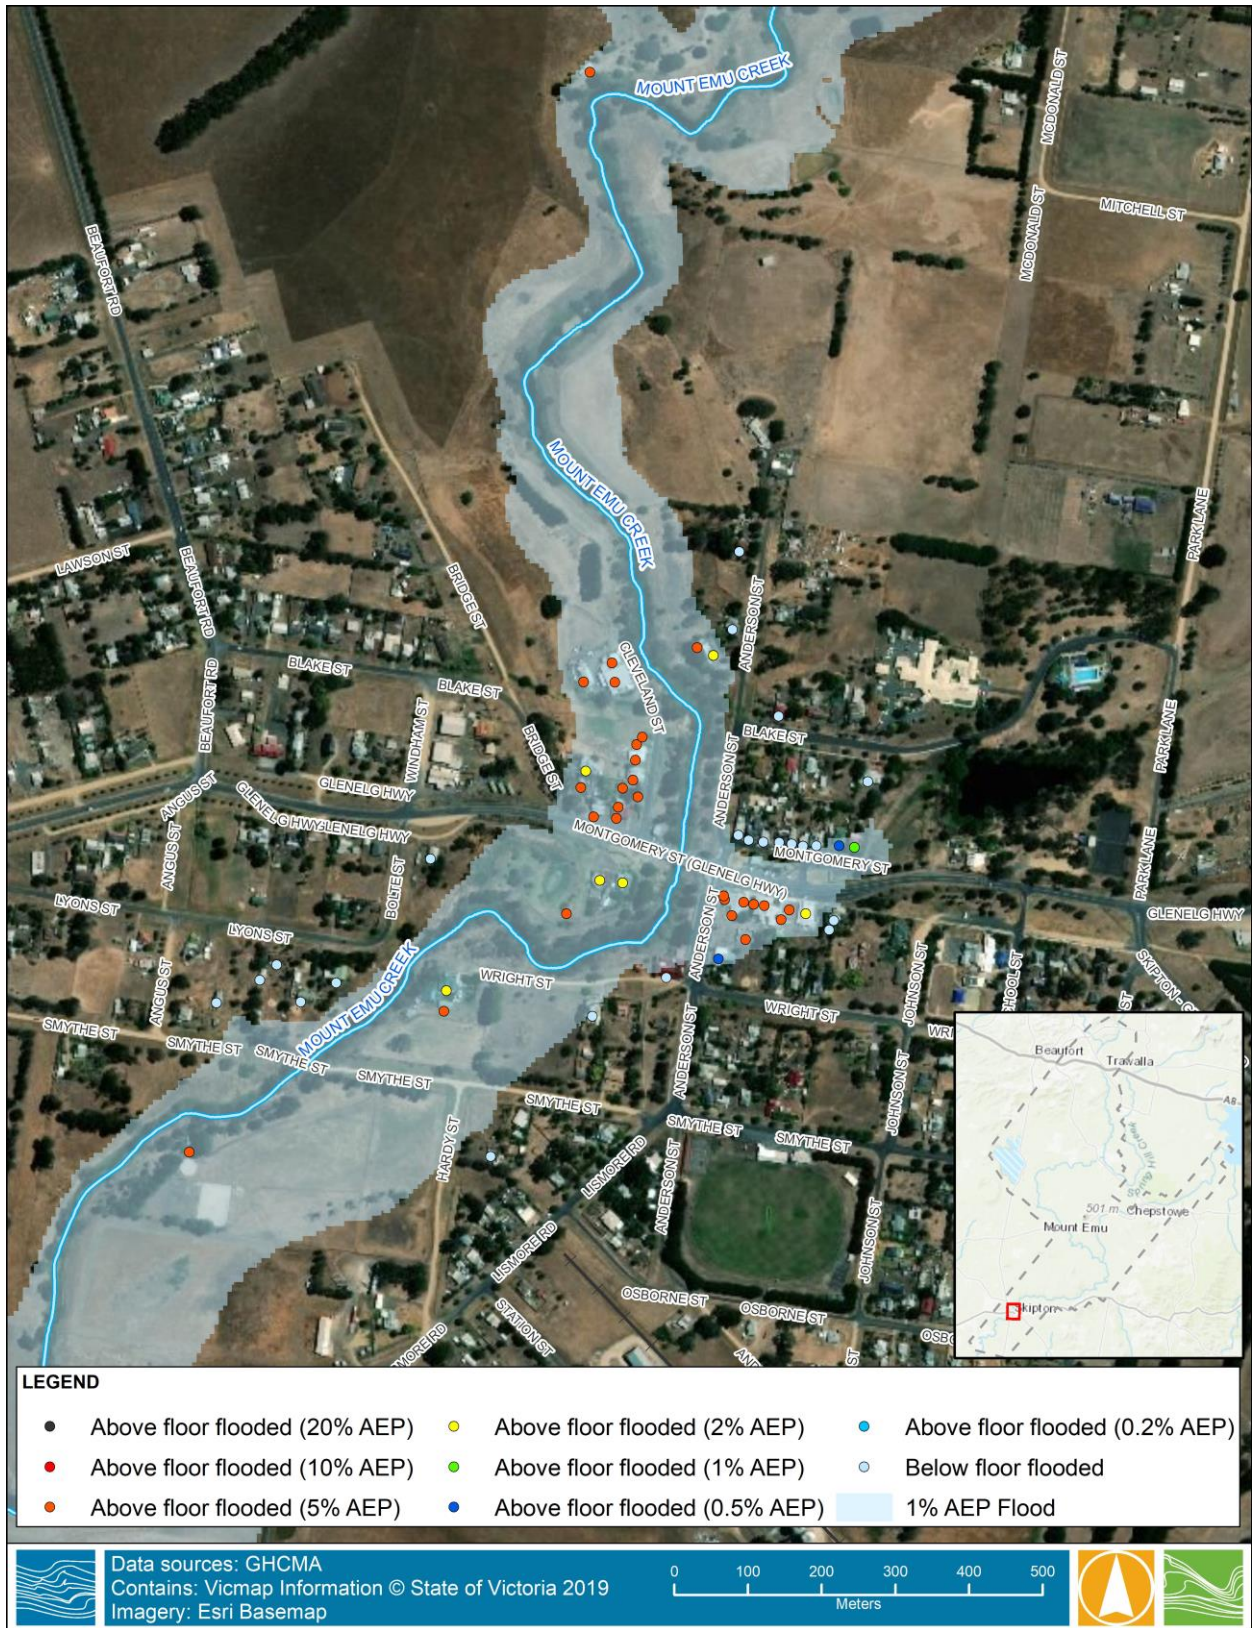
FIGURE 2-6 FLOODING ABOVE FLOOR (SKIPTON)

The existing conditions 1% AEP flood extent and the properties flooded above floor during the range of modelled design events are shown in Figure 2-6 to Figure 2-8.

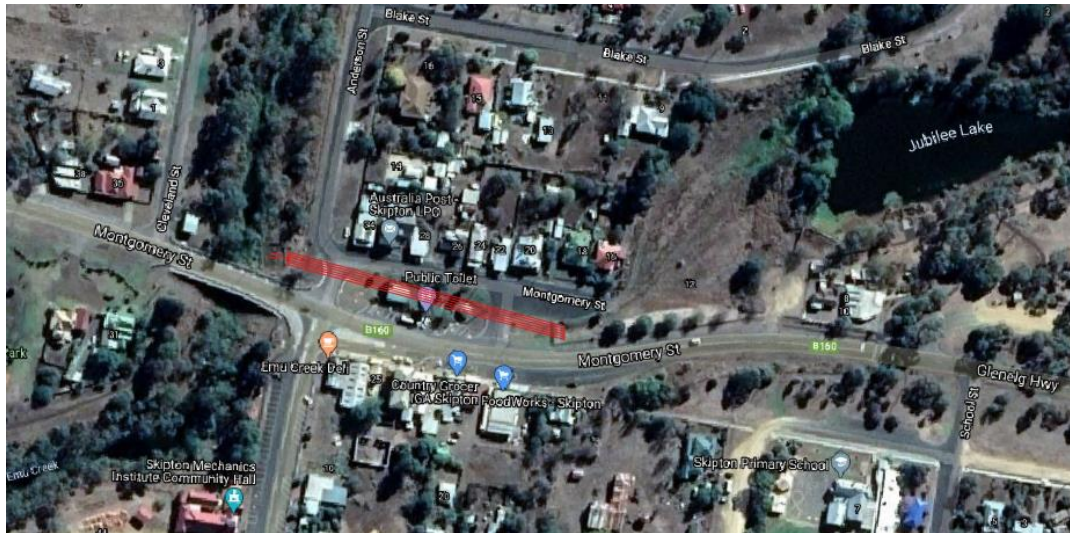
FIGURE 4-1 LOCATION OF MITIGATION CULVERTS IN SKIPTON

An upgrade to culverts in Skipton downstream of Jubilee Lake increasing the conveyance of spills from the lake to Mt. Emu Creek was recommended in the Skipton Flood Investigation¹, and constructed by Corangamite Shire in mid-2016. The impact of the 2016 flood was considered to have been largely mitigated by these culverts. The culverts direct overflows from Jubilee Park Lake through the Skipton town centre into Mt. Emu Creek. The culverts were upgraded from two reinforced concrete pipes to six box culverts. These mitigation culverts and their location are shown in Figure 4-1 and Figure 4-2.

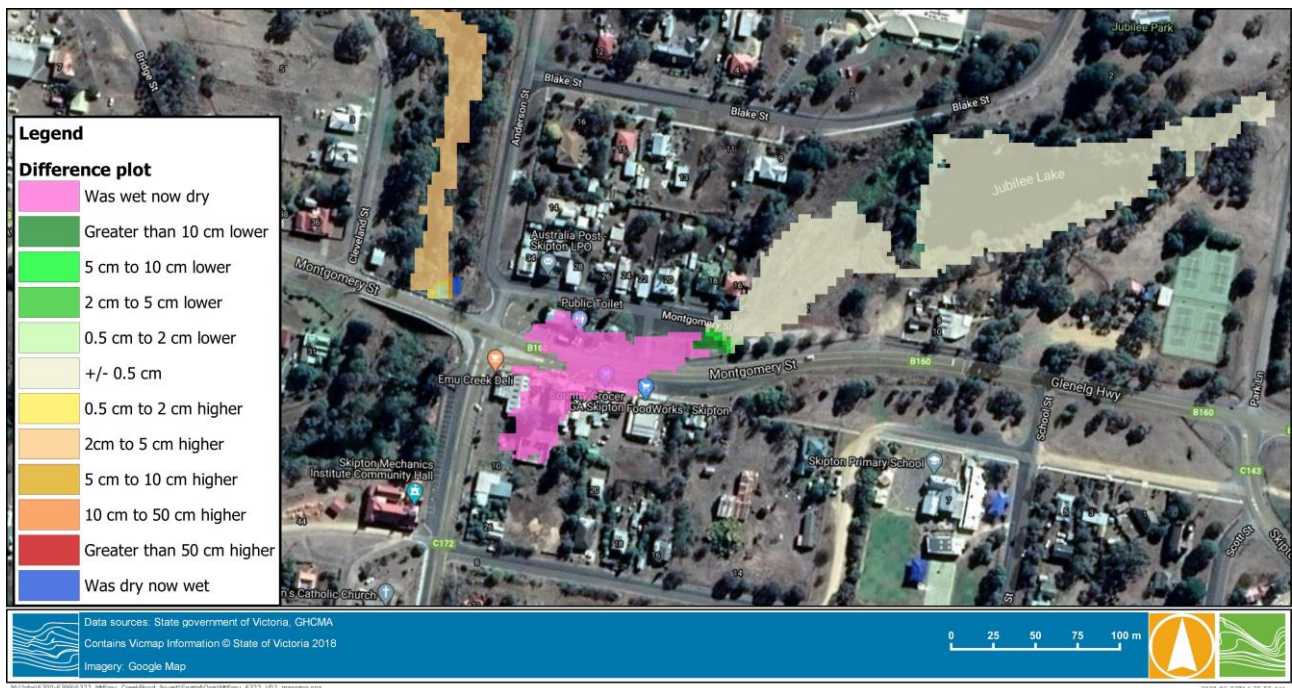
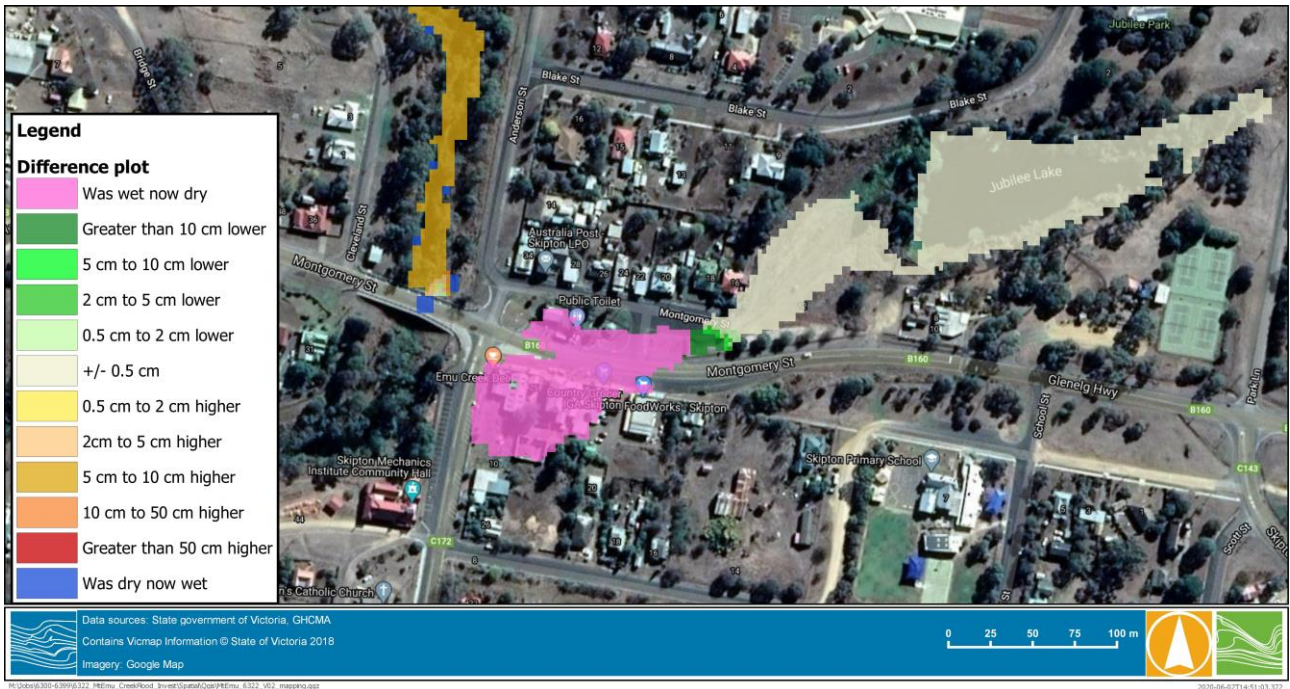
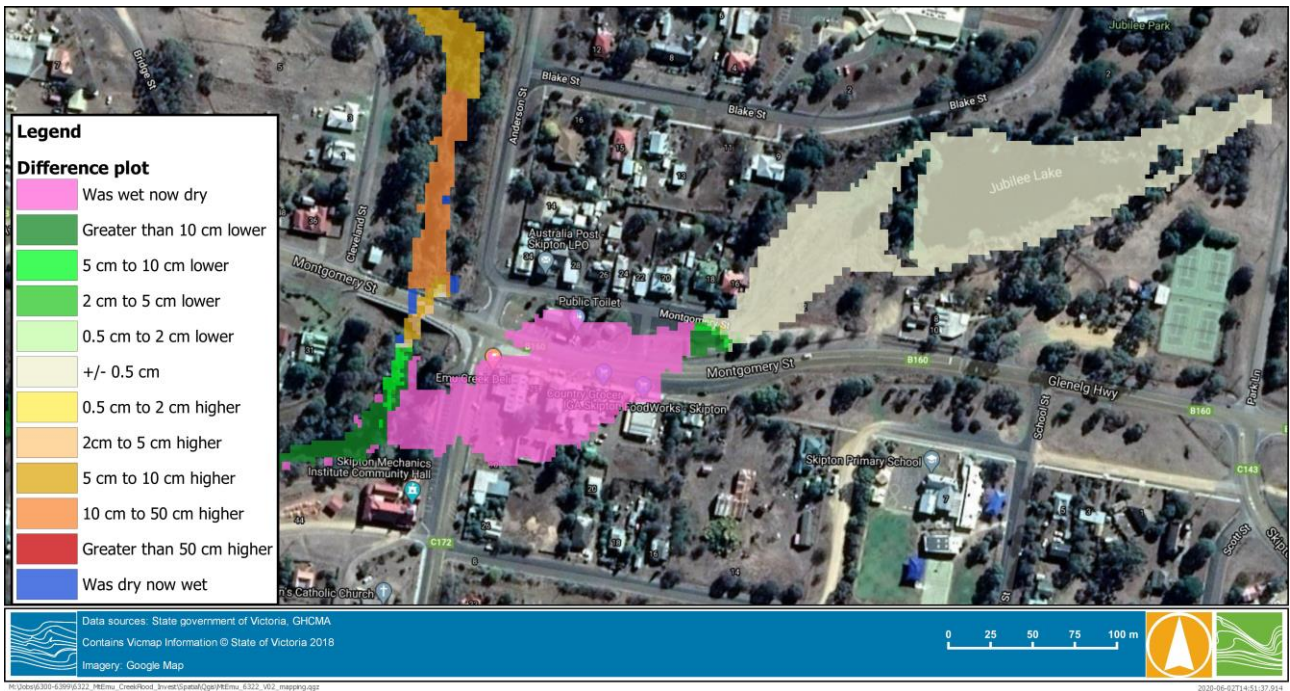
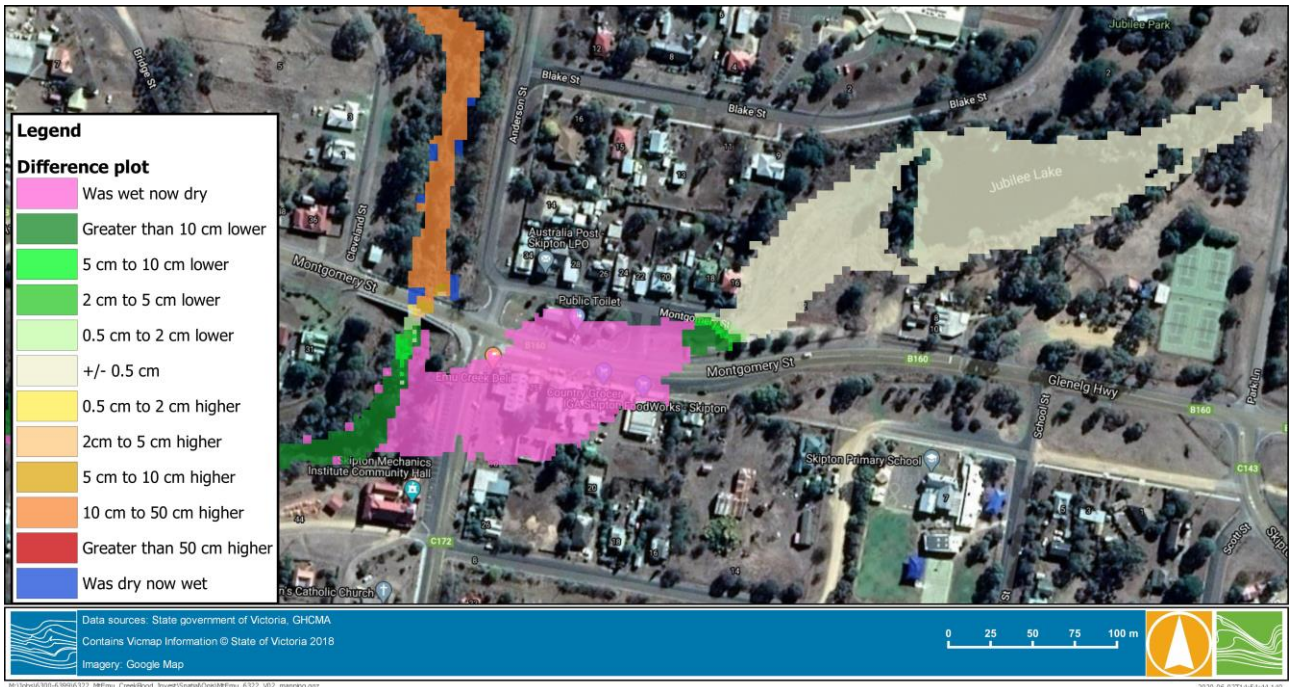
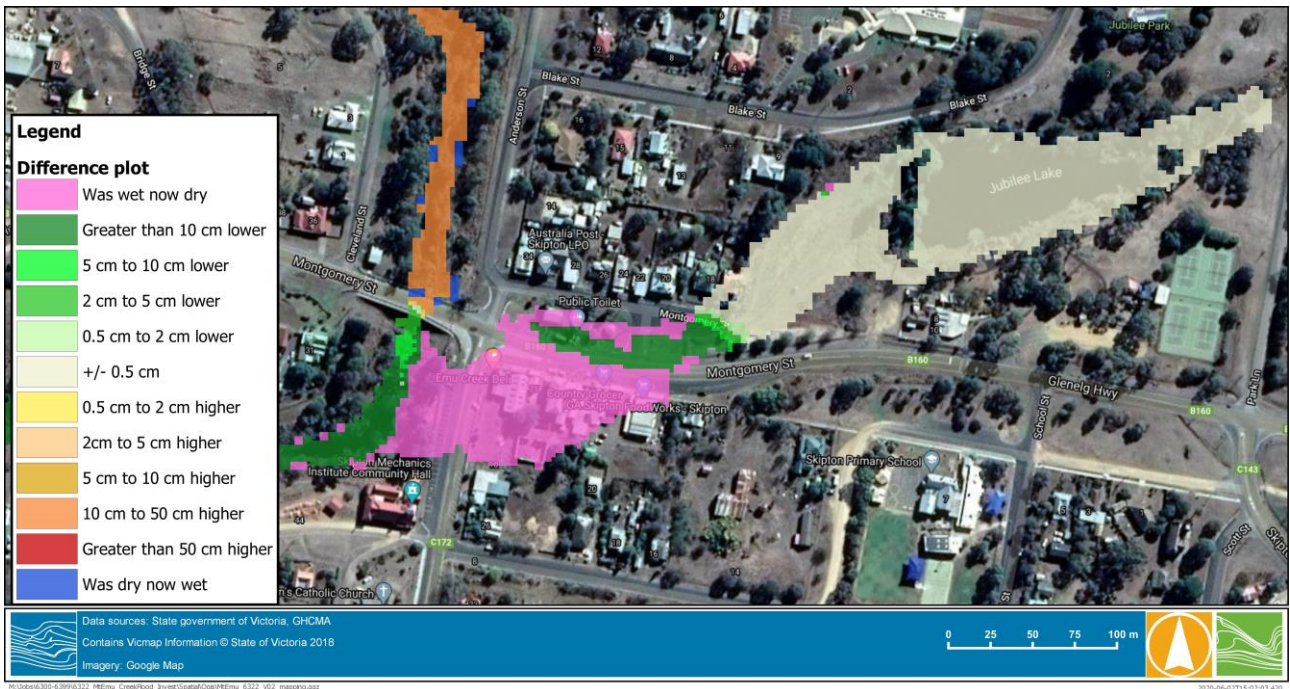
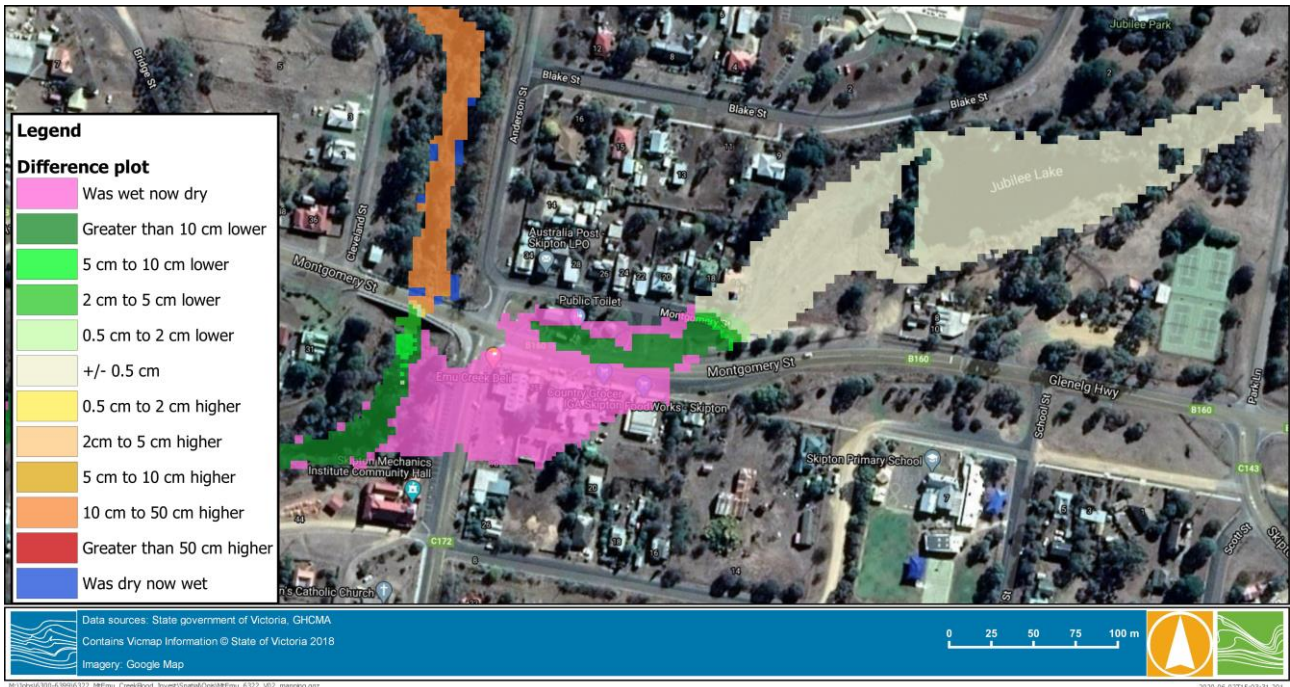
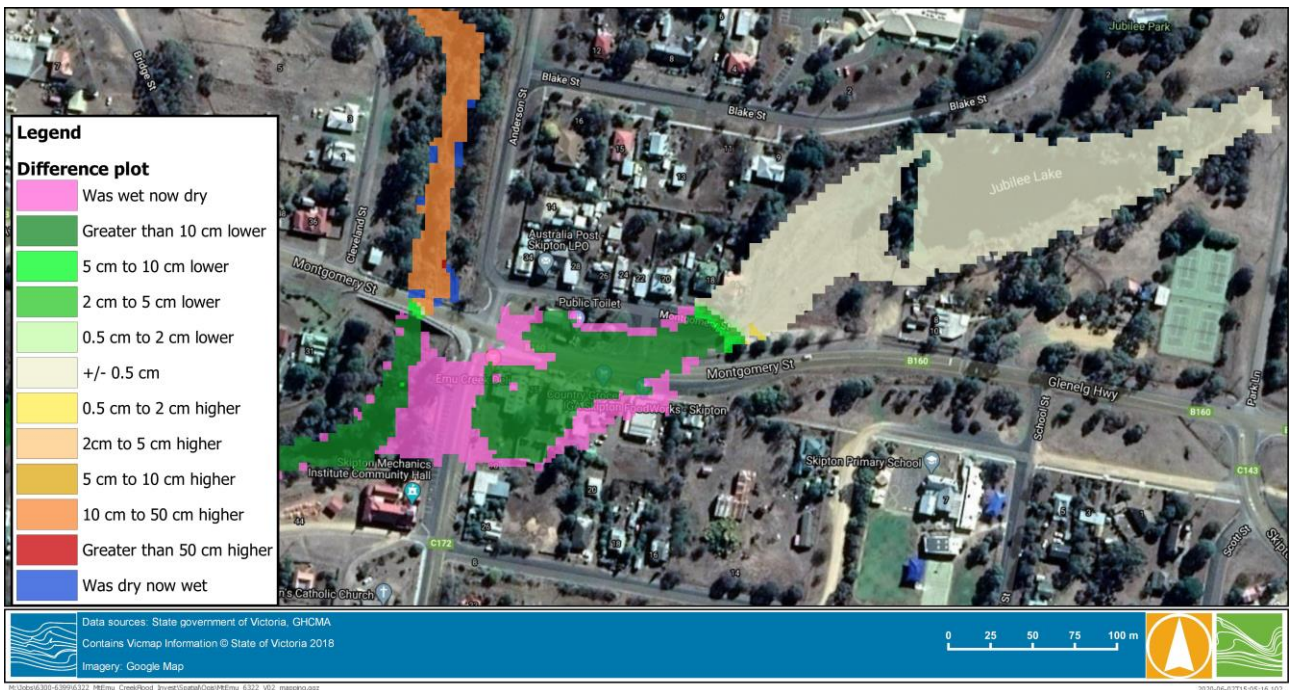
Figure 4-3 to Figure 4-9 show change in flood level as a result of the of the Jubilee Park Lake outflow upgrade. Plots have been provided for each modelled AEP ranging from the 20% AEP to the 0.2% AEP flood event. Under pre-mitigation conditions, Montgomery St was overtopped, and properties were flooded during a 20% AEP event. Under post-mitigation conditions, Montgomery St was not overtopped in events smaller than the 1% AEP event and properties were not flooded until the 0.2% AEP event. It should be noted that the Jubilee Park Lake outflow is the dominant flooding mechanism up to the 10% AEP event. For the 5% AEP and above, overbank flooding from the Mt. Emu Creek is the dominant flood mechanism, inundating properties above floor. This shows the mitigation measures have significantly reduced the impact of flooding via flow from Jubilee Park Lake, but have not changed the impact of inundation from Mt. Emu Creek.

Overall, the mitigation works completed in mid-2016 can significantly reduce flood risk from Jubilee Park Lake outflows up to 1% AEP event but inundation via Mt. Emu Creek will still occur in events as low as a 5% AEP.

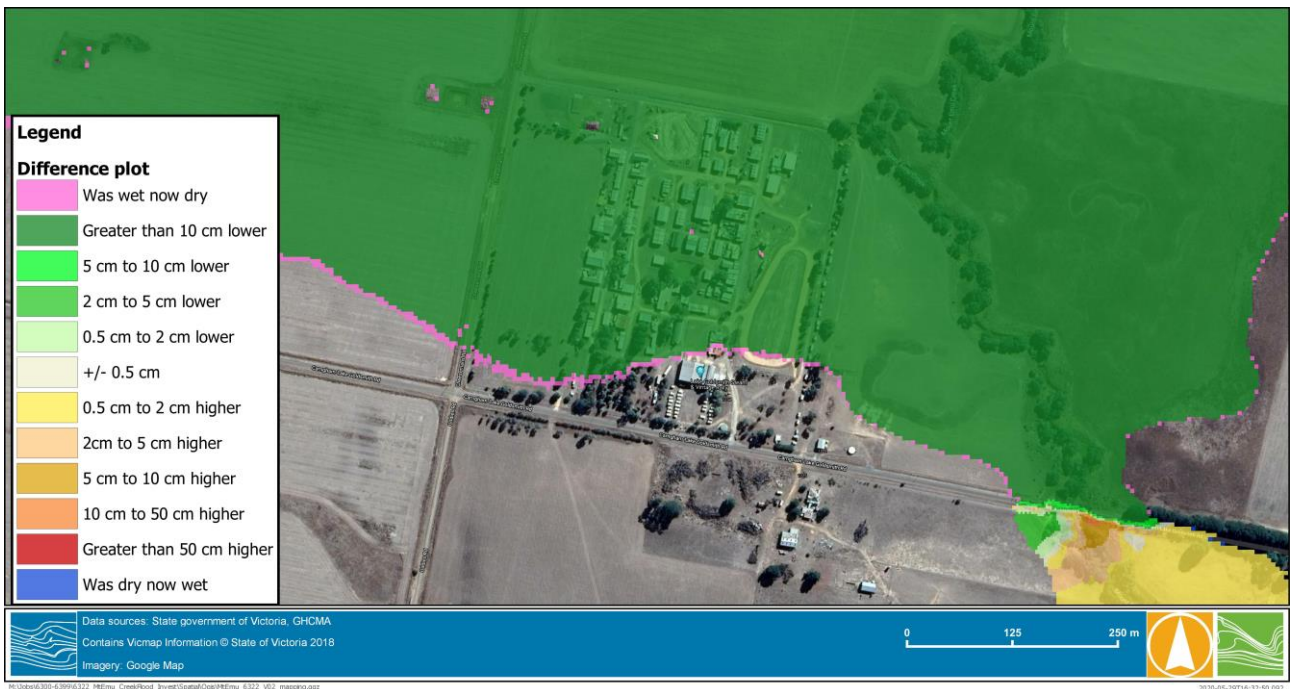
FIGURE 5-8 OPTION 2 - WATER LEVEL DIFFERENCES AT LGSPS SITE

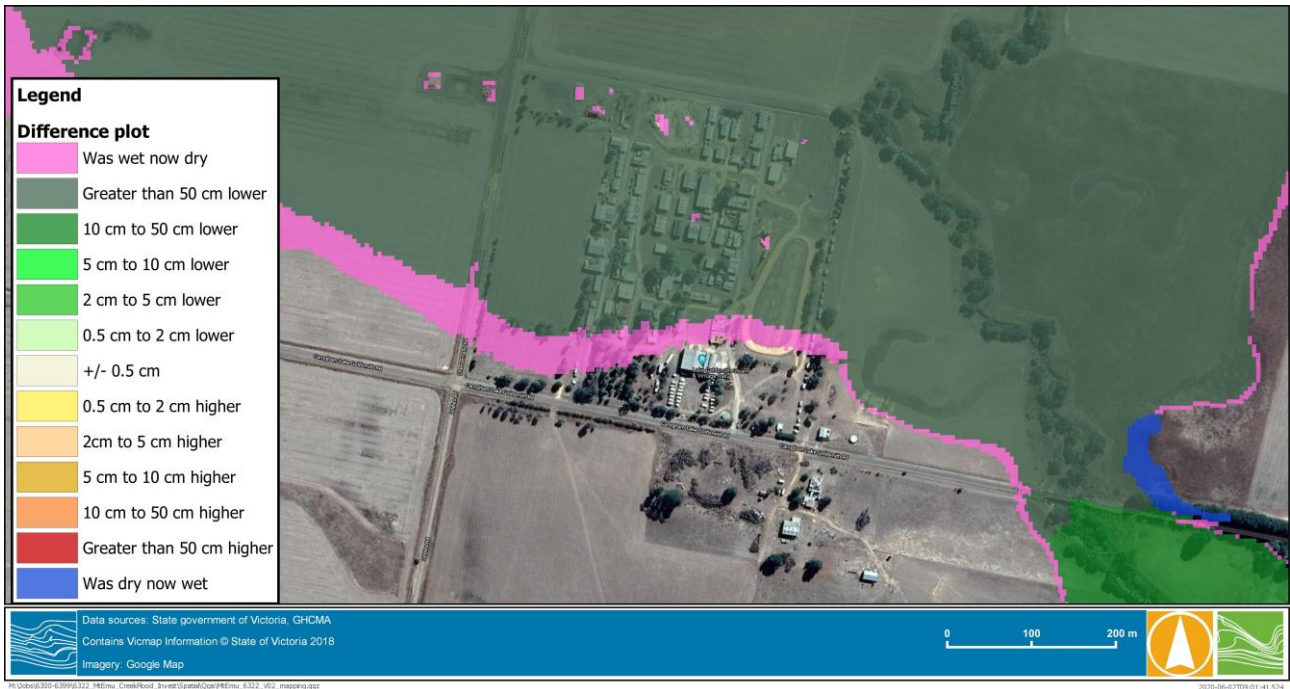
FIGURE 5-14 OPTION 3 – WATER LEVEL DIFFERENCES AT LGSPS SITE

1% AEP water levels immediately upstream of the bridge and within LGSPS site were reduced by more than 60 cm and the flood extent was noticeably reduced as shown in Figure 5-14. However, the site was still inundated by up to 50 cm.

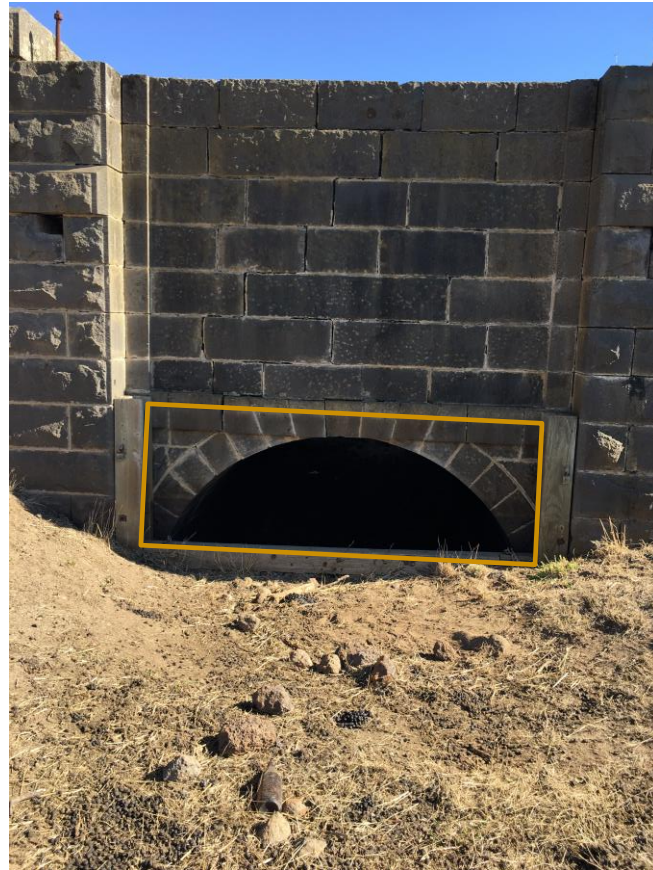
FIGURE 5-17 PICTURE OF THE BRIDGE AT LAKE GOLDSMITH DIVERSION CHANNEL

The diversion channel was modelled open and closed for the 2016 flood event and the 1% AEP design event. The modelling results of “channel open” and “channel closed” were compared for each scenario.

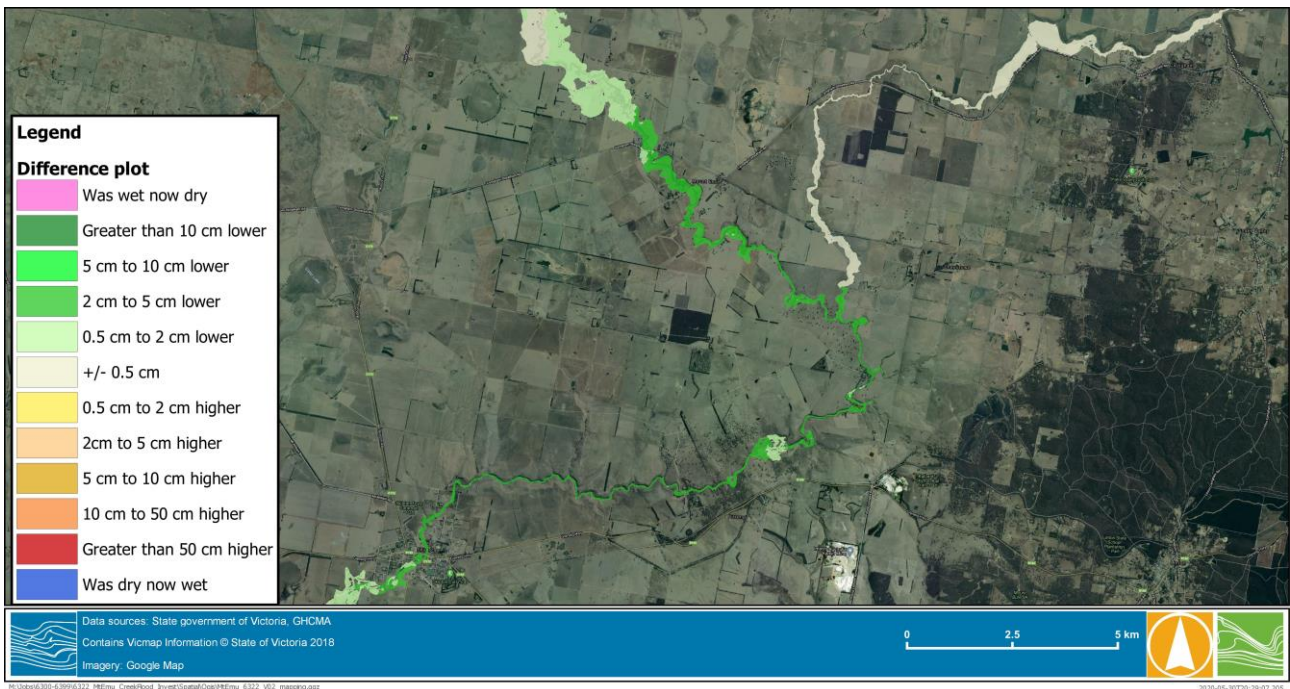
FIGURE 5-19 OPTION 4 - WATER LEVEL DIFFERENCES (2016 EVENT) – CHANNEL OPEN VERSUS CHANNEL CLOSED AT DOWNSTREAM OF LAKE GOLDSMITH

Further downstream of Lake Goldsmith, the average water level reduction along Mt. Emu Creek was around 2 cm, as shown in Figure 5-19. Figure 5-20 shows the difference in water levels at Skipton, with the average decrease in water levels less than 2 cm with no significant reduction of flood extent.

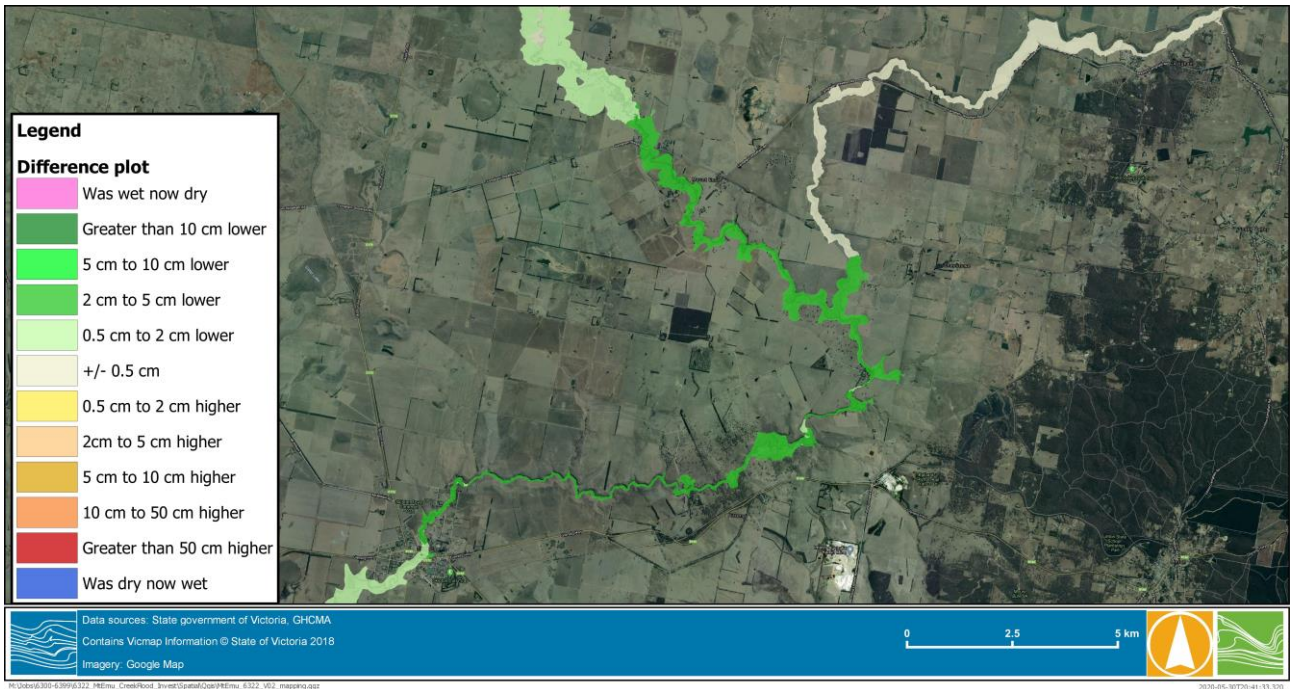
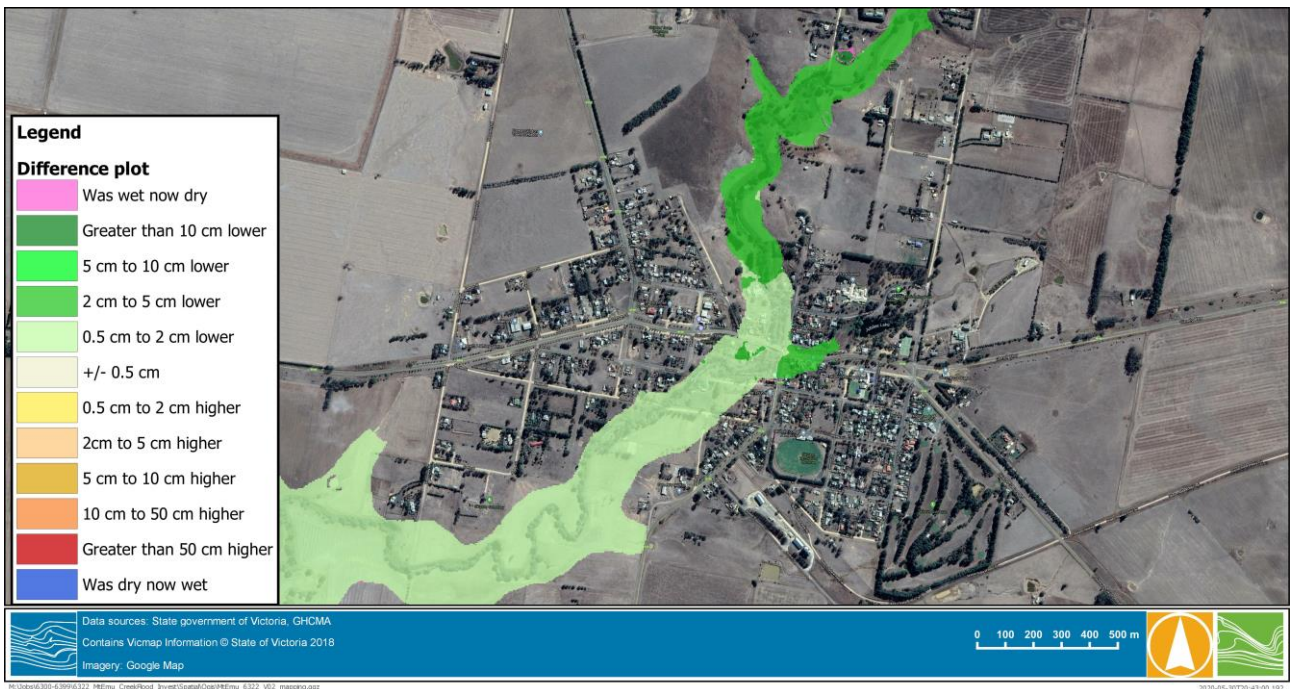
Changes to flood levels due to opening the Lake Goldsmith diversion channel at Cheesemans Road in a 1% AEP event are shown from Figure 5-21 to Figure 5-23. The larger event (i.e. the 2016 event was smaller than a 1% AEP event) caused a greater reduction in flood levels. Water levels were reduced by approximately 2.6 cm within the LGSPS site. Downstream of Lake Goldsmith, water levels along Mt. Emu Creek were reduced by 2 cm to 4 cm. The maximum reduction in water levels within Skipton was just above 2 cm as shown in Figure 5-23.

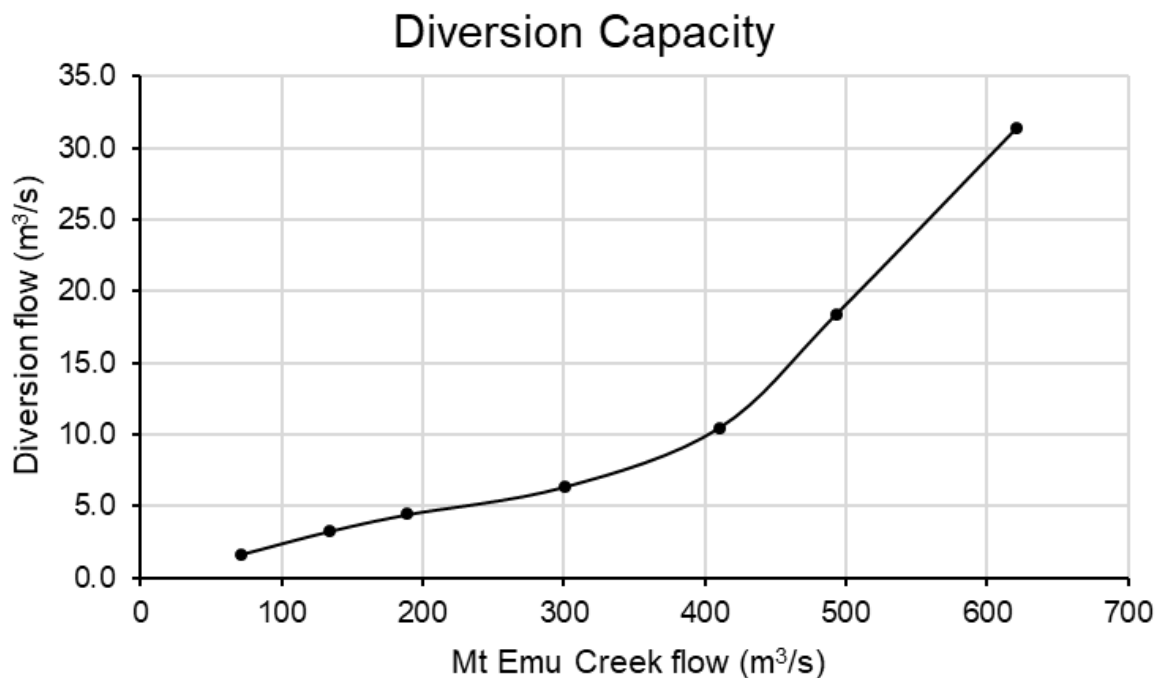
FIGURE 5-24 DIVERSION CAPACITY FOR A RANGE OF DESIGN FLOWS IN MT EMU CREEK

A detailed review of the capacity of the existing diversion channel and its flood mitigation benefit at Skipton was undertaken using the critical duration for each AEP at Lake Goldsmith. The flows split between Mt. Emu Creek and the existing diversion channel in the range of the design AEP events was calculated and are shown in Table 5-1 and Figure 5-24.

AEP	Flows in Mt Emu Creek (m ³ /s)	Flows in diversion channel (m ³ /s)	Diversion of % Mt Emu Creek flows
20%	71	1.7	2.4%
10%	134	3.3	2.5%
5%	189	4.5	2.4%
2%	301	6.4	2.1%
1%	410	10.5	2.6%
0.50%	493	18.4	3.7%
0.20%	621	31.4	5.1%

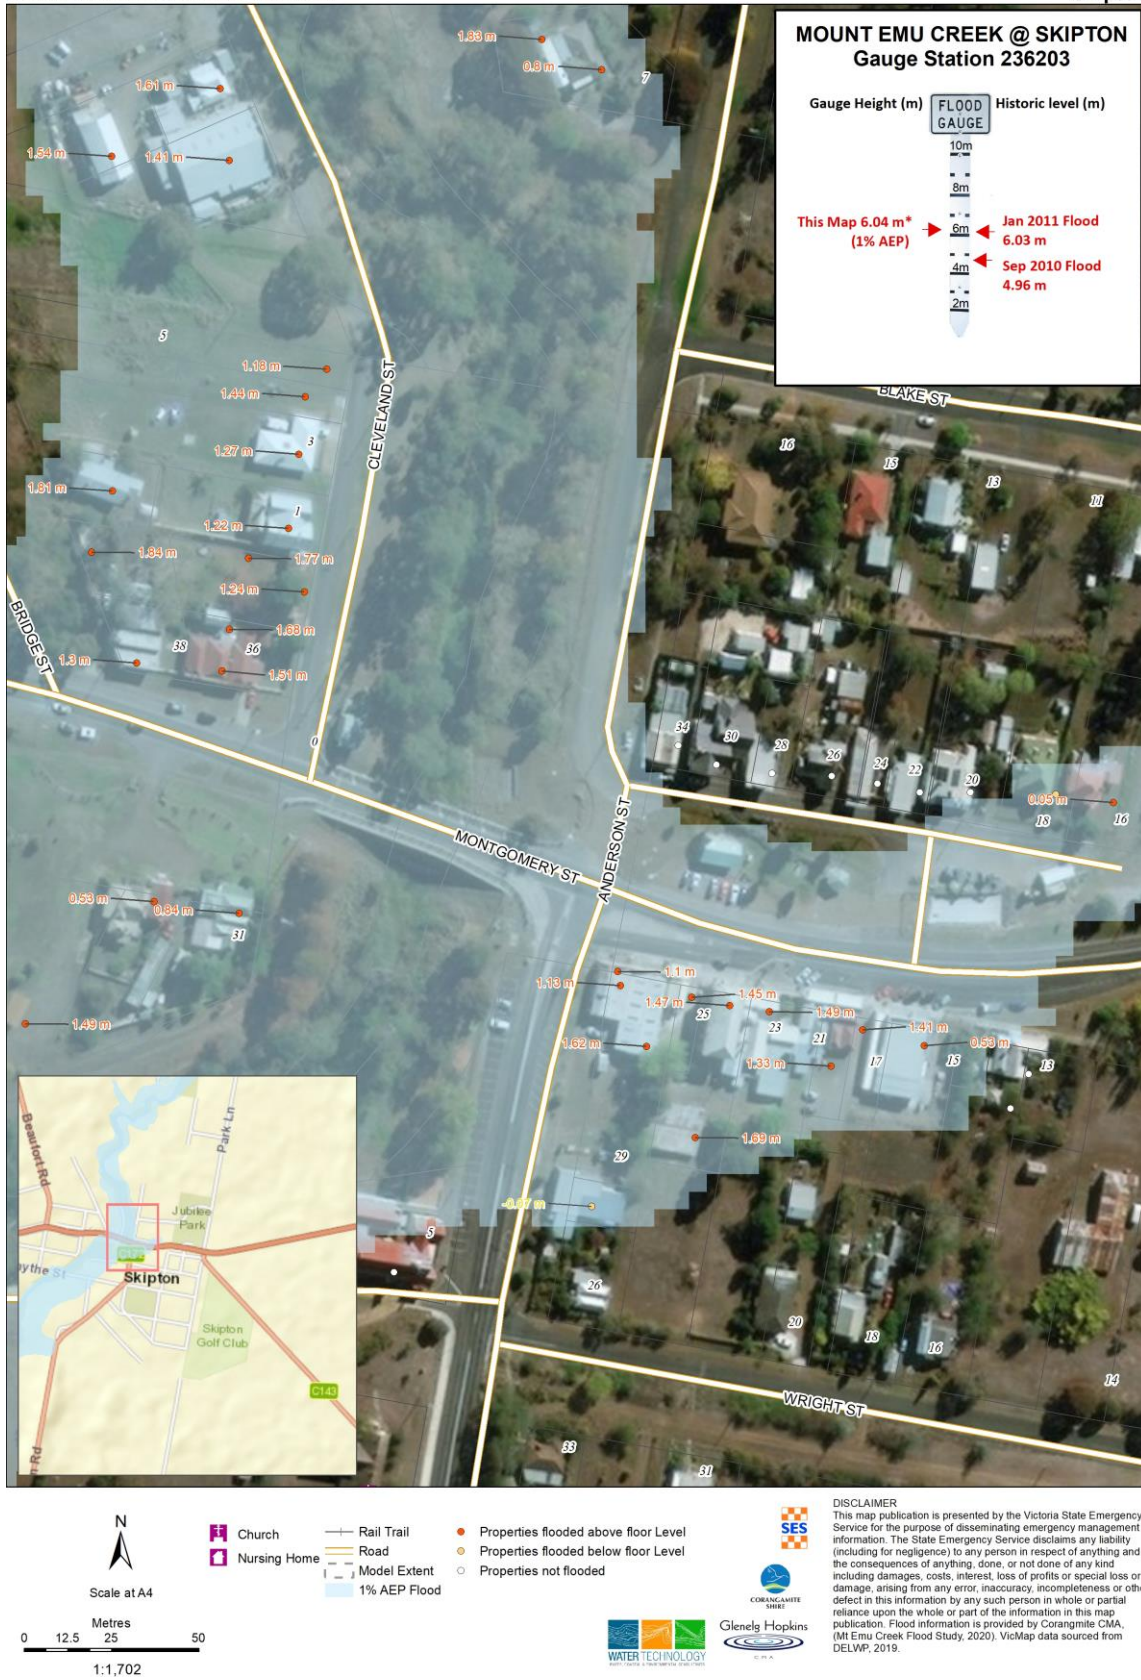
FIGURE 5-25 1% AEP ABOVE FLOOR INUNDATION IN SKIPTON

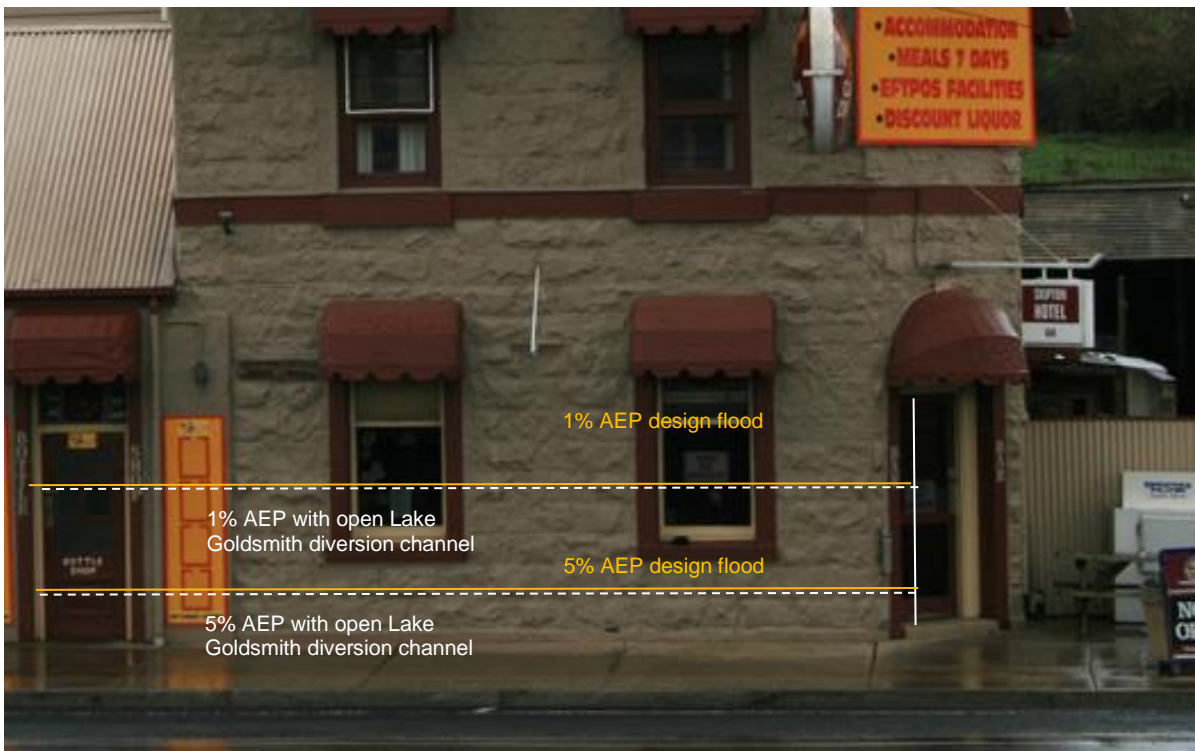
FIGURE 5-26 DEMONSTRATION OF THE REDUCTION IN 1% AEP ABOVE FLOOR INUNDATION AT THE SKIPTON HOTEL

- The reduction in water levels was shown to be too minor to warrant investigation of the measure. In a 1% AEP flood event properties are flooded by a significant margin, as shown in Figure 5-24, opening the diversion channel may reduce inundation depths at these properties by up to 2cm, making no perceivable difference to flood damage. An example of this is shown in Figure 5-26.

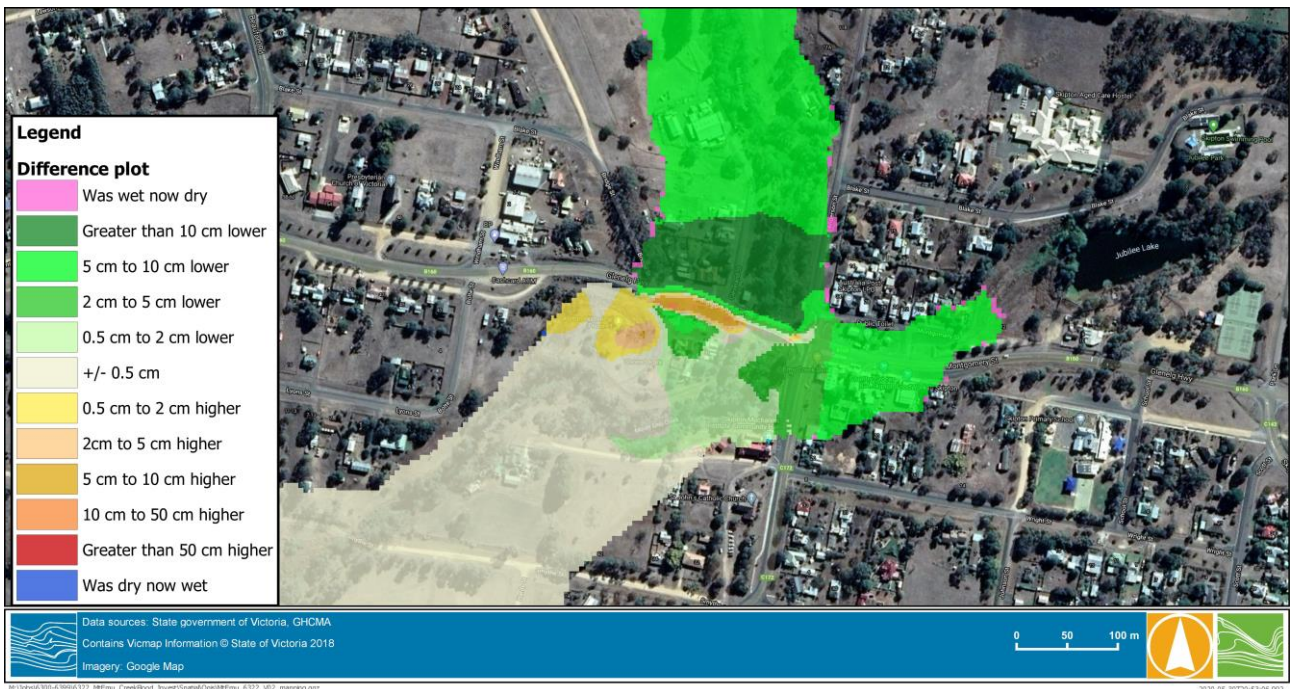
FIGURE 5-29 OPTION 5 - WATER LEVEL DIFFERENCES AT SKIPTON - GLENELG HIGHWAY BRIDGE OPEN

Figure 5-29 shows the change in water levels at Skipton as a result of opening of Glenelg Highway bridge. Water levels immediately upstream of the bridge were reduced by 10 to 15 cm, and water levels at Stewart Park were increased by less than 5 cm. There were some small decreases in flood extent at Anderson Street, Bridge Street and east of Montgomery Street.

Opening the Glenelg Highway bridge reduced the flood levels on the properties north of the bridge (i.e. > 10 cm); however, flood risk on other surrounding properties within Skipton was not shown to be significantly

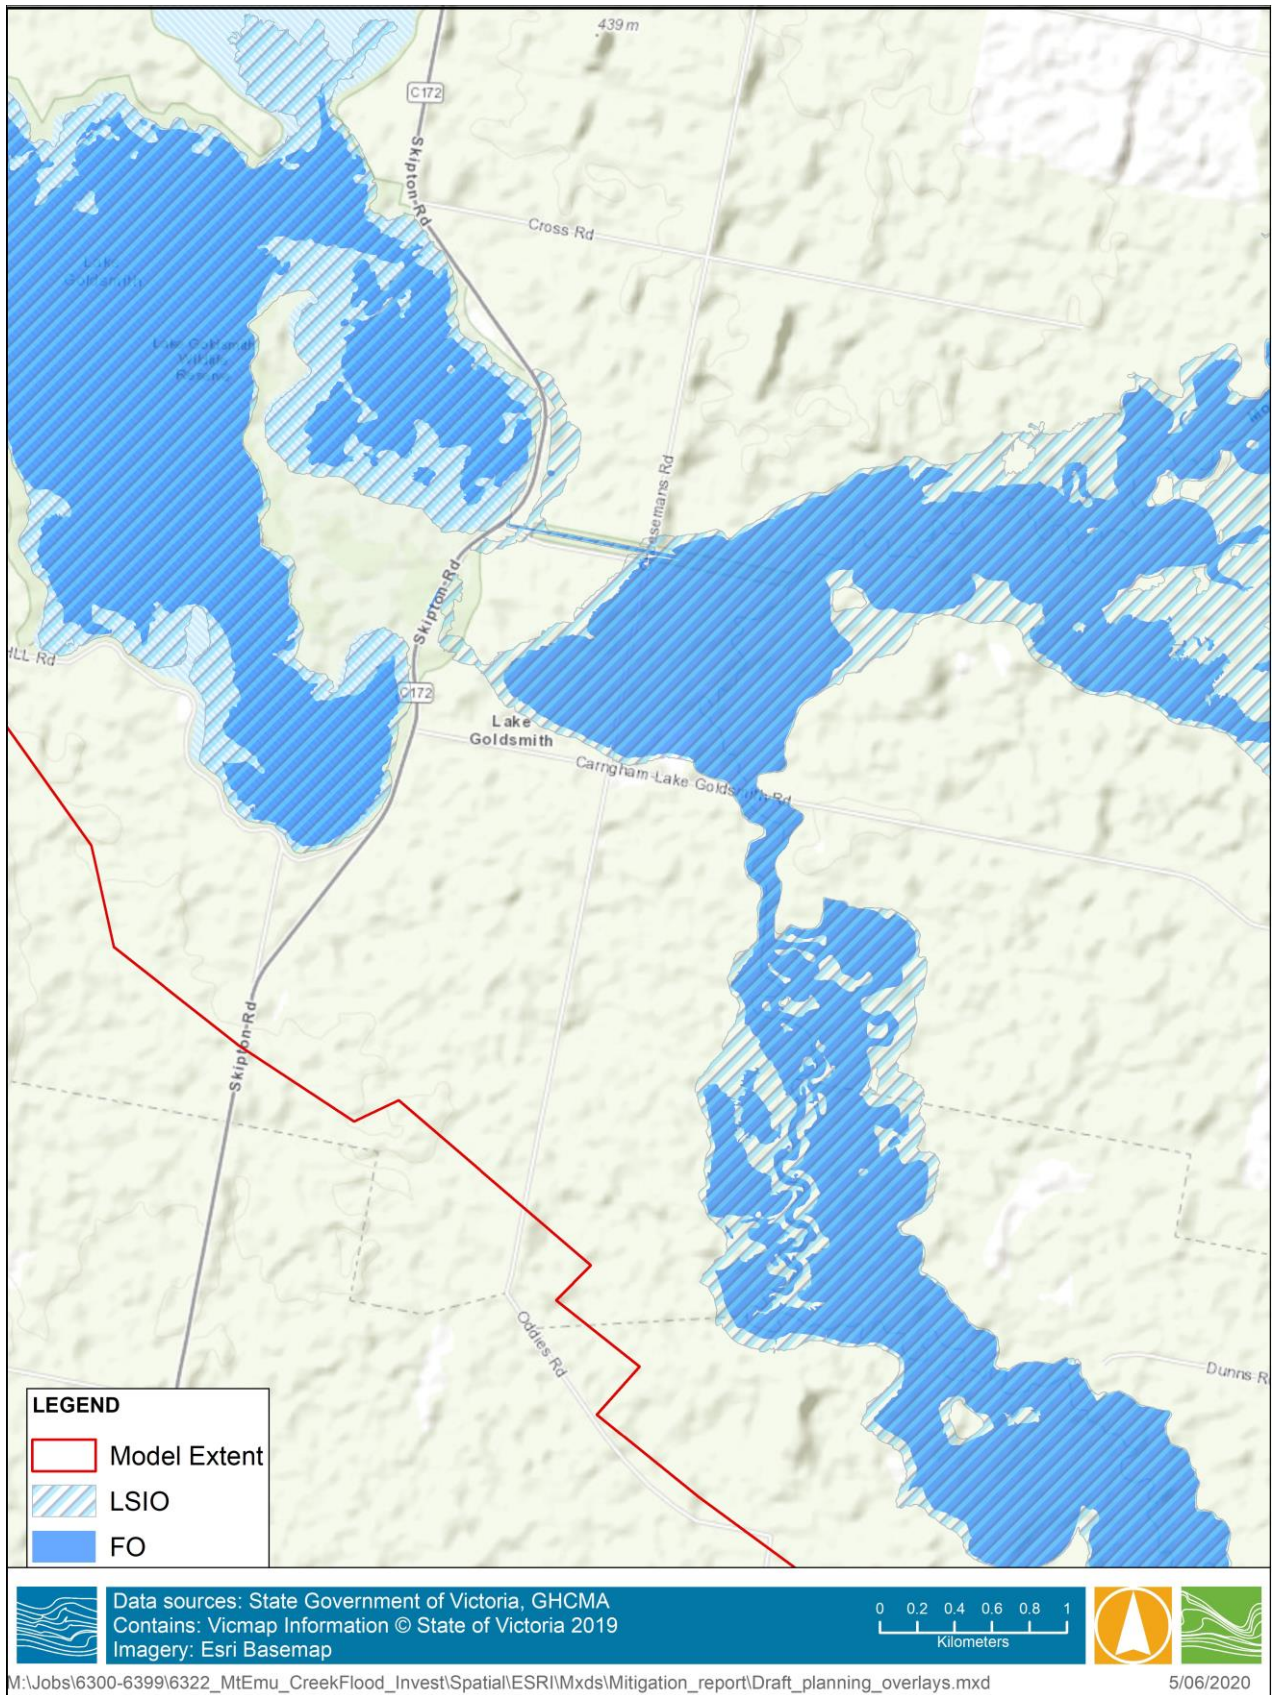
FIGURE 5-36 FLOOD RELATED PLANNING CONTROLS – LAKE GOLDSMITH

In assessing how flood controls should be applied within the Upper Mt. Emu Creek Catchment area, consideration must be given to both the extent of 1% AEP flood event as produced by the hydraulic modelling results and the nature of the flood risk. Figure 5-32 and Figure 5-33 show the draft planning overlays produced in this study for Pyrenees Shire Council and Corangamite Shire Council. Figure 5-34 to Figure 5-36 show the planning overlays in key townships within Pyrenees Shire and Figure 5-37 shows the township of Skipton within Corangamite Shire.
