# Flood Warning Report

## Upper Mt. Emu Creek Flood Investigation

Glenelg Hopkins CMA

16 June 2020

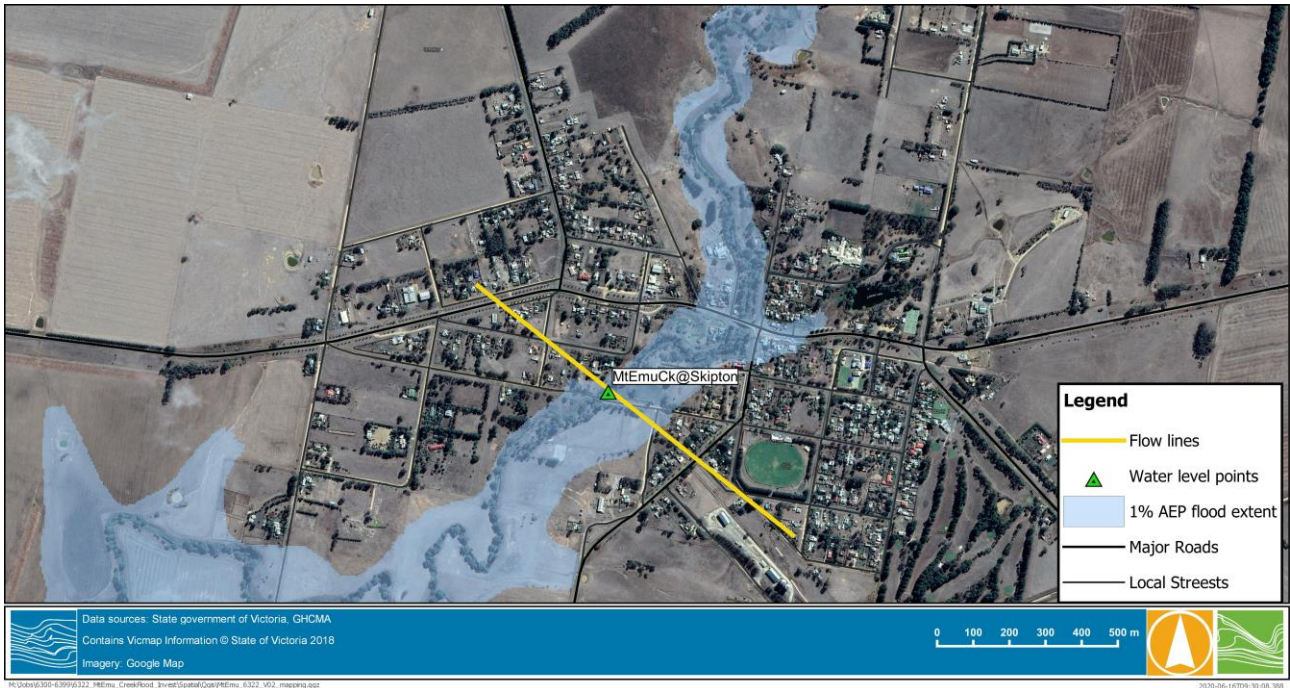
**FIGURE 4-1 RATING CURVE EXTRACTION LOCATION AT THE SKIPTON GAUGE**

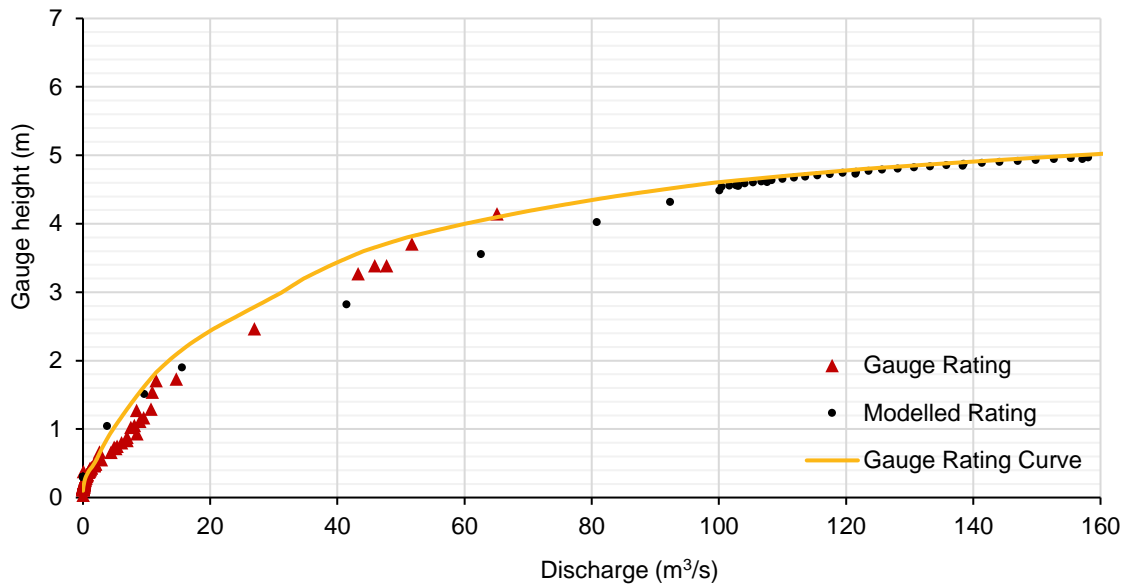
**FIGURE 4-2 RATING CURVE COMPARISON AT THE SKIPTON GAUGE, TOP: LOW FLOWS; BOTTOM: HIGH FLOWS**

The hydraulic model will provide more reliable estimates of the relationship between flowrate and height at water levels above 4.5 m. Above 5.0 m the existing gauge rating curve is likely to underestimate flow rate. The gauge rating curve indicates a water level of 6.0 m the flowrate is 400 m<sup>3</sup>/s, whereas the modelled theoretical rating is around 450 m<sup>3</sup>/s. These differences are considered relatively minor.

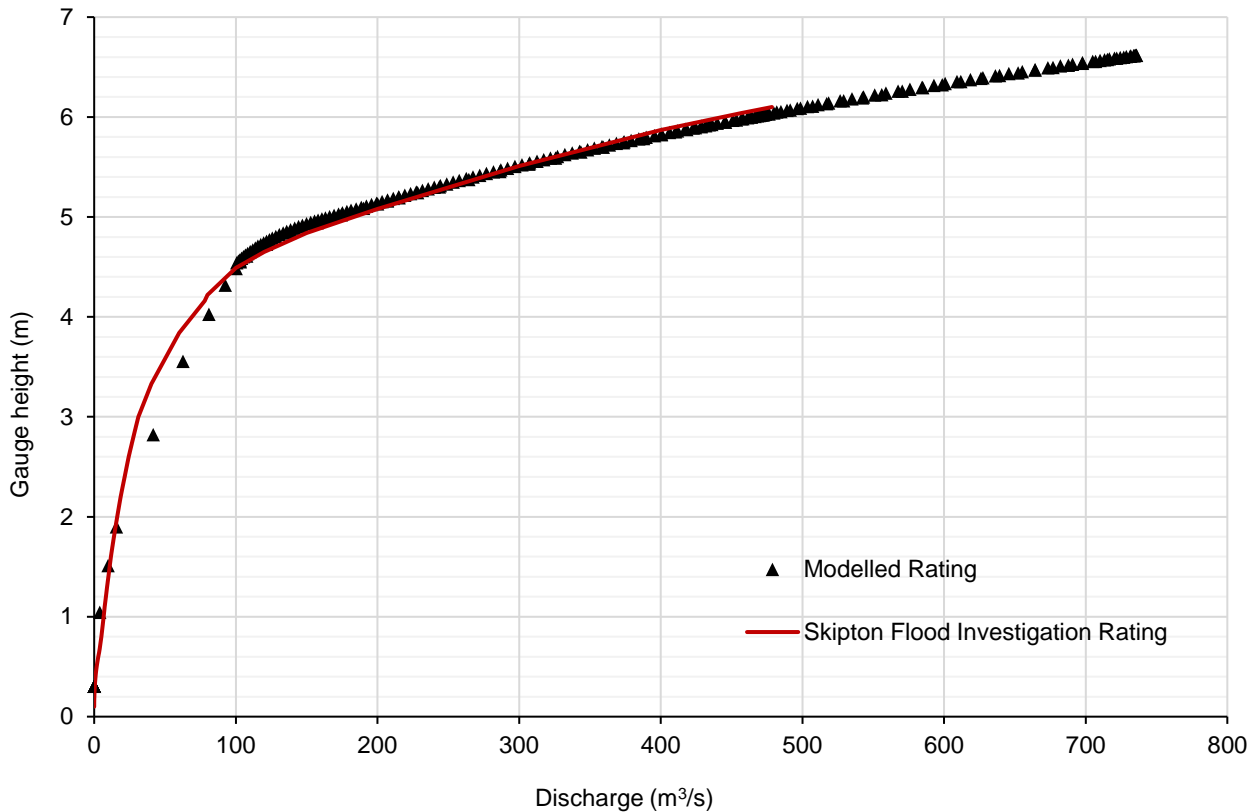
**FIGURE 4-3 RATING CURVE COMPARISON BETWEEN THE RATING DETERMINED DURING THE SKIPTON FLOOD INVESTIGATION AND THIS PROJECT**

During the Skipton Flood Investigation<sup>1</sup> a modelled rating curve was determined for Skipton was determined, how this rating curve compares to that determined during this project is shown below in Figure 4-3. The modelled ratings show a very close match.

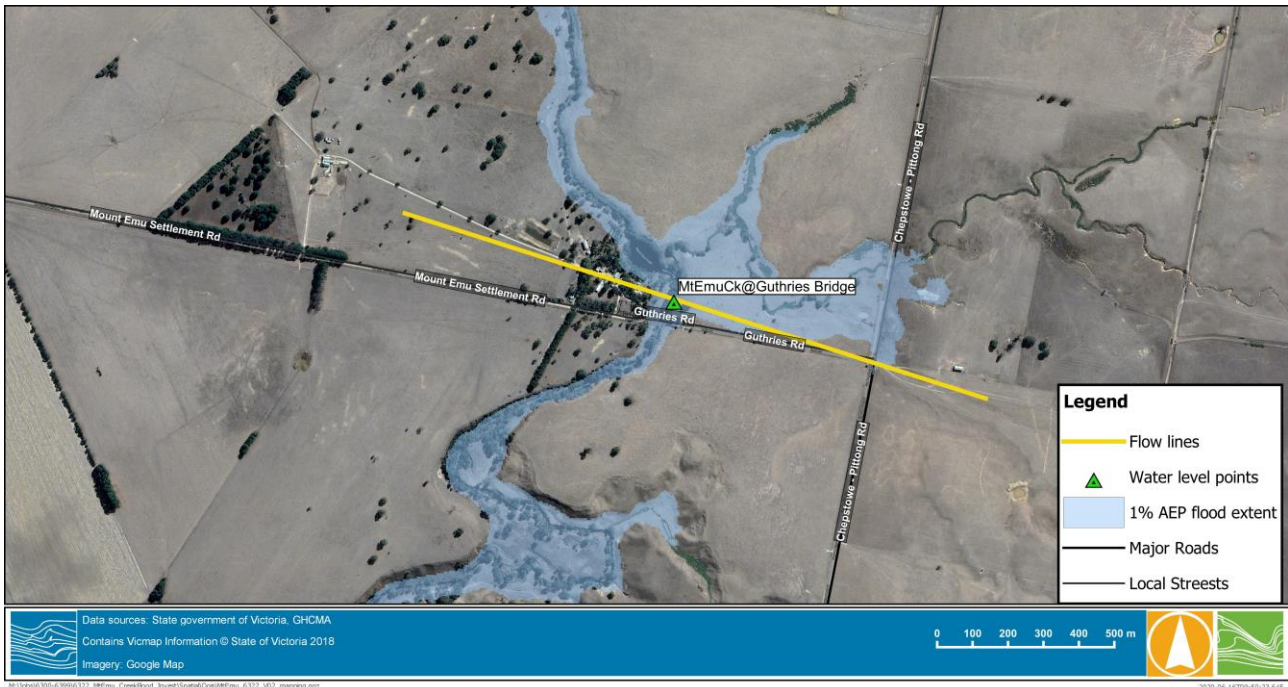
**FIGURE 4-5 MODELLED THEORETICAL RATING CURVE EXTRACTION LOCATION AT GUTHRIES BRIDGE GAUGE**

The extraction location of the theoretical rating curve is shown in Figure 4-5.

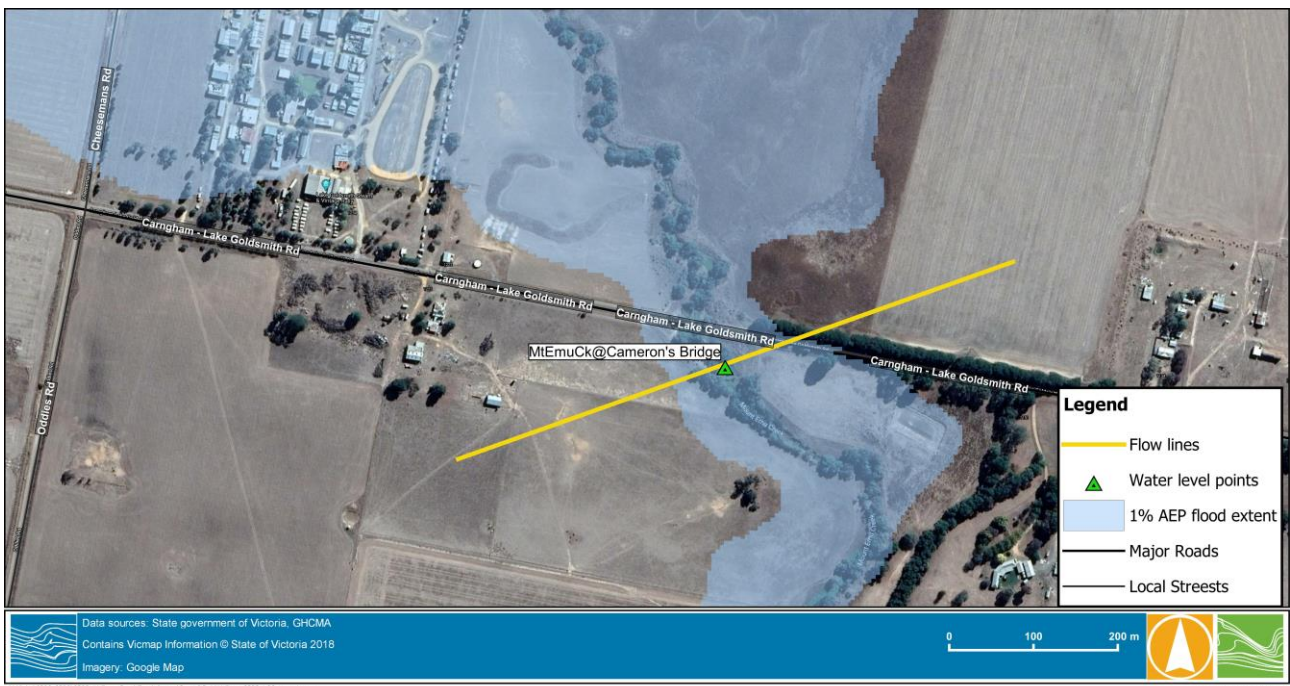
FIGURE 4-7 MODELLED THEORETICAL RATING CURVE EXTRACTION LOCATION AT CAMERON BRIDGE

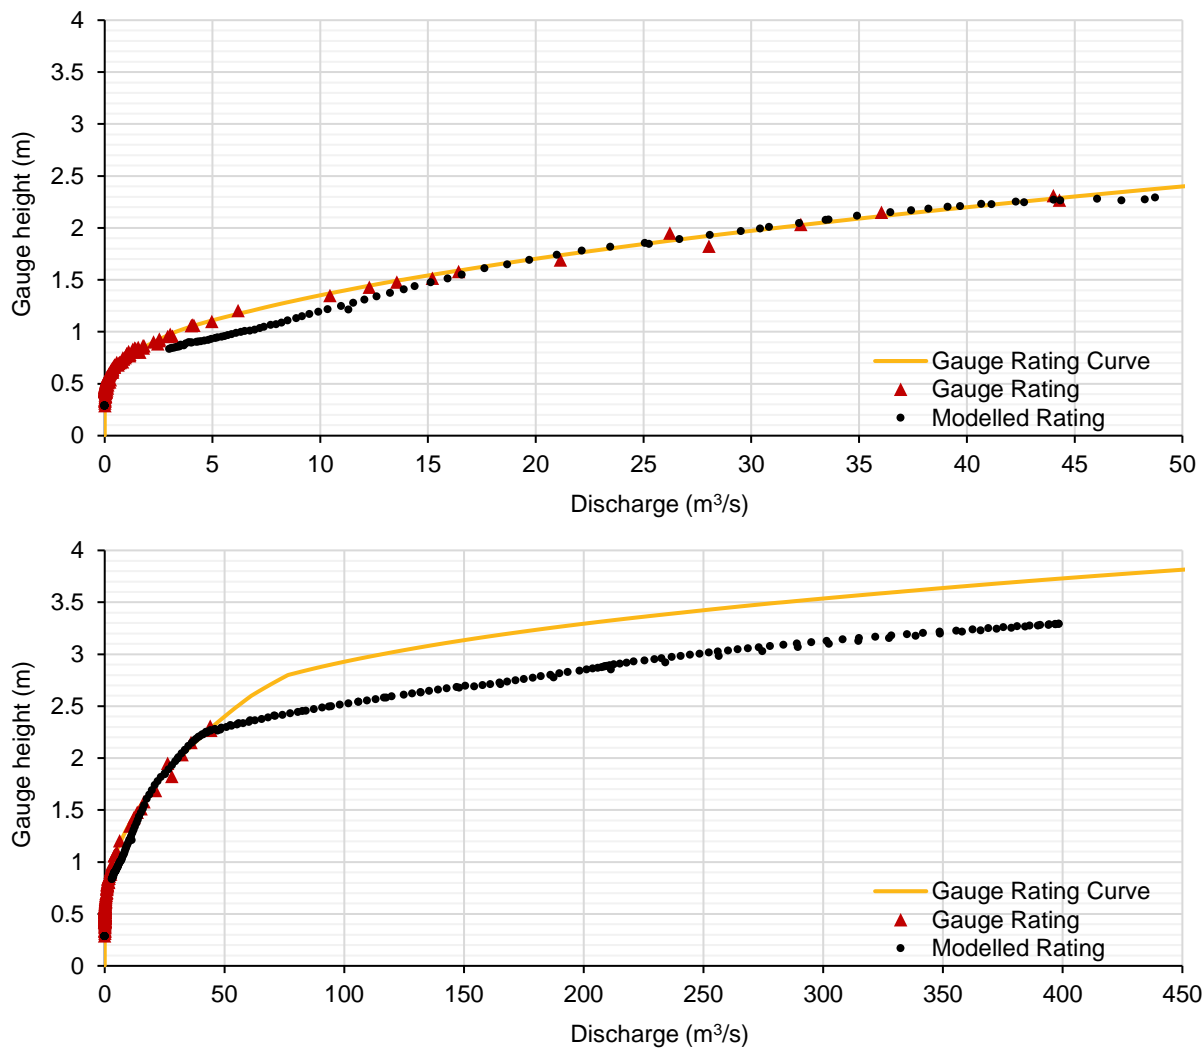
**FIGURE 4-9 RATING CURVE COMPARISON AT MENA PARK, TOP: LOW FLOWS; BOTTOM: HIGH FLOWS**

The surveyed zero gauge level of the Mena Park gauge is 350.8 m AHD. As shown in Figure 4-9, there is a clear separation between the existing measurement based rating curve and the modelled theoretical rating curve at around a flow of 45 m<sup>3</sup>/s or water level of 2.2 m, there is limited recorded data above this point and the existing rating curve is extrapolated. The modelled theoretical rating curve is expected to give a more realistic height and flow relationship above this point.

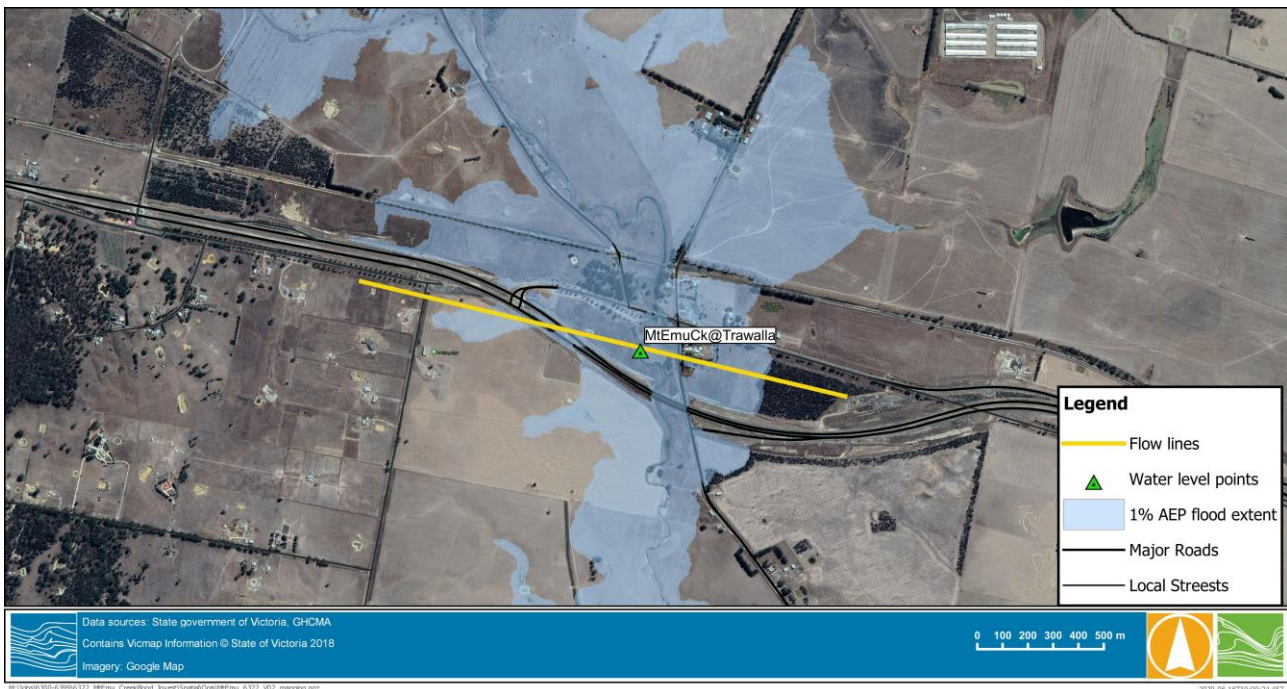
**FIGURE 4-11 MODELLLED THEORETICAL RATING CURVE EXTRACTION LOCATION AT TRAWALLA**

The location of the extracted theoretical rating curve is shown in Figure 4-11.

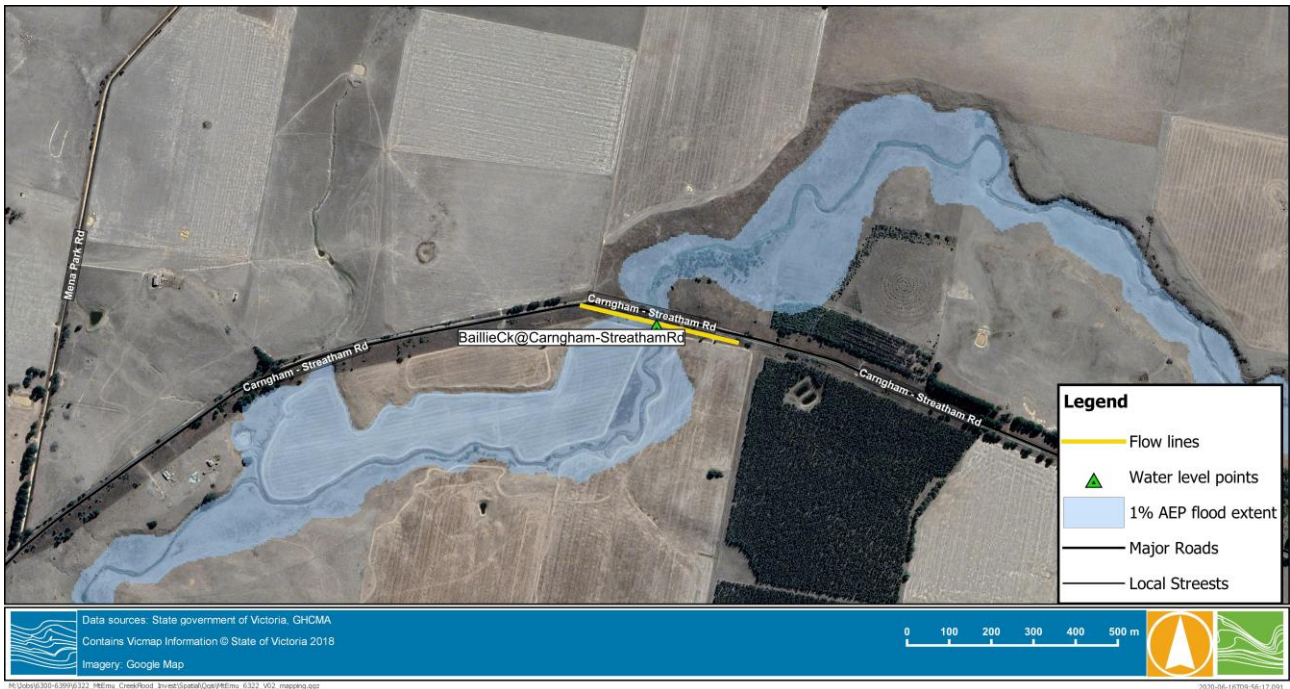
**FIGURE 4-13 MODELLED THEORETICAL RATING CURVE EXTRACTION LOCATION AT CARNGHAM – STREATHAM ROAD**

The location of the extracted theoretical rating curve is shown in

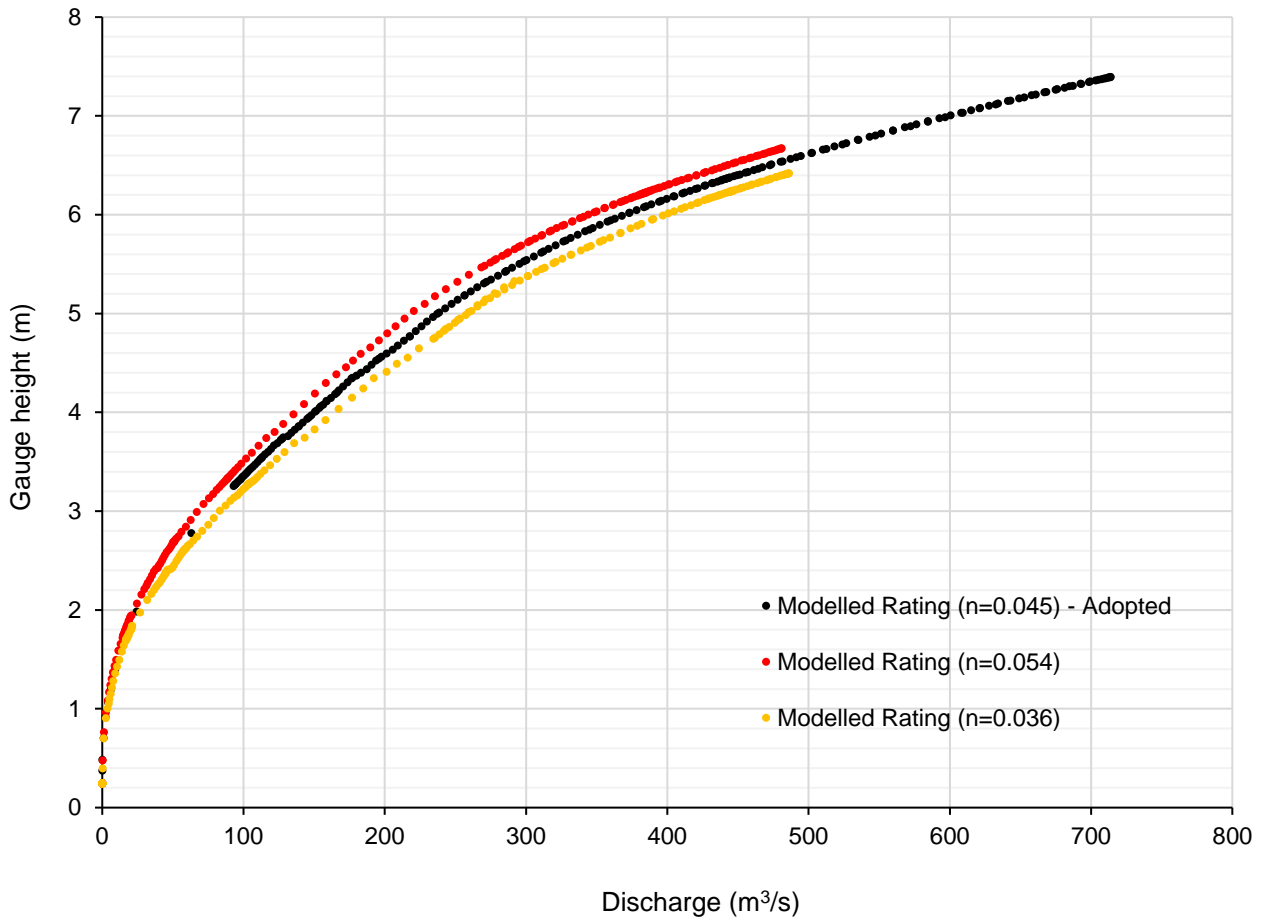
**FIGURE 5-3 ROUGHNESS SENSITIVITY TESTING AT GUTHRIES BRIDGE**

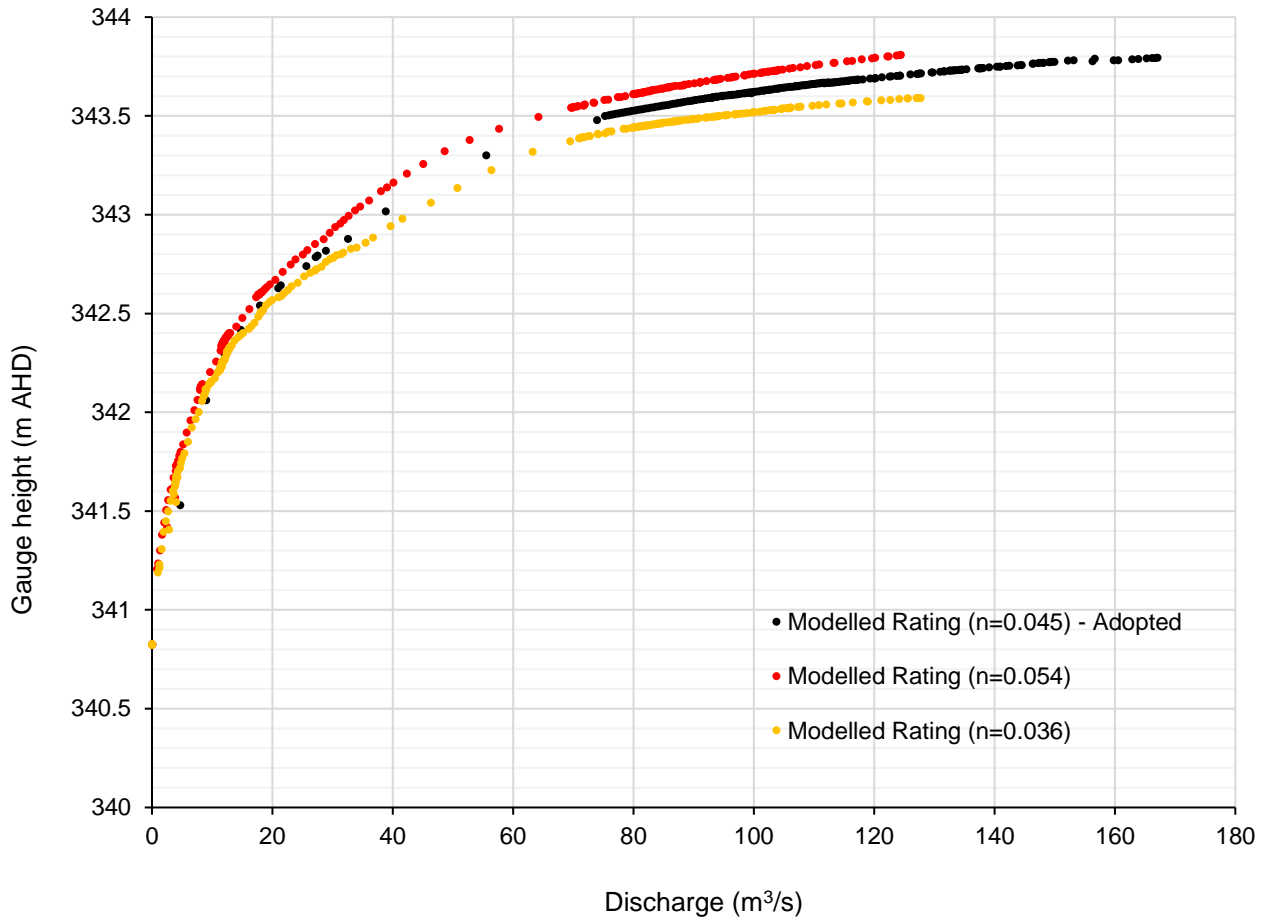
**FIGURE 5-4 ROUGHNESS SENSITIVITY TESTING AT CARNGHAM STREATHAM ROAD**

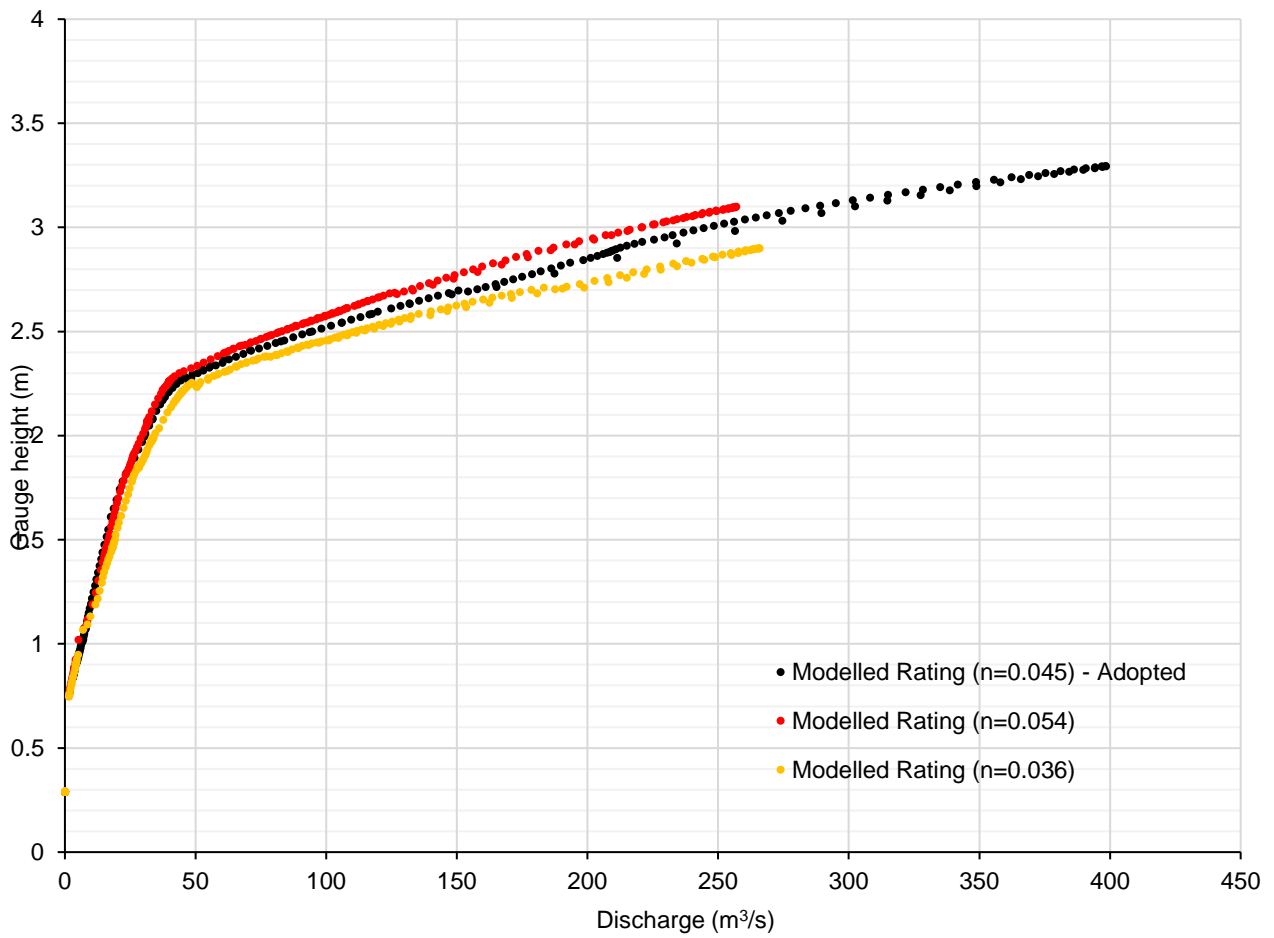
**FIGURE 5-6 ROUGHNESS SENSITIVITY TESTING AT MENA PARK**

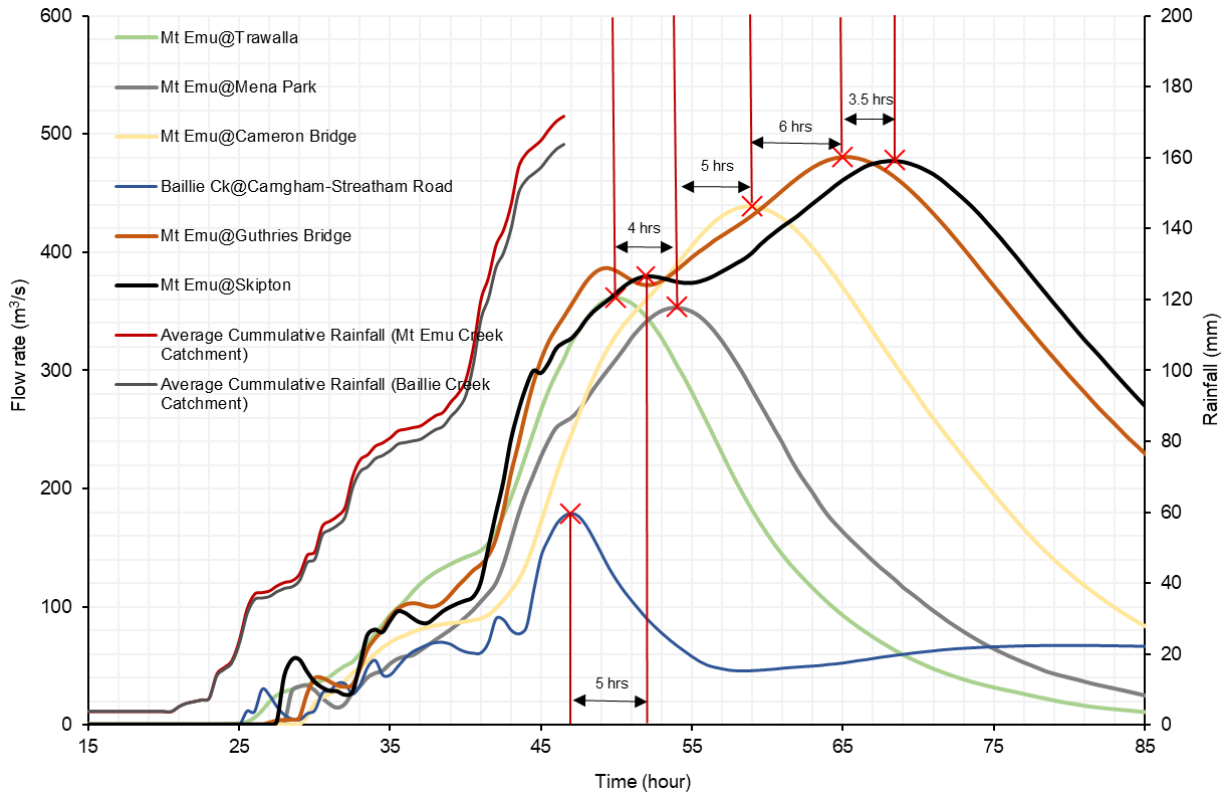
**FIGURE 6-1 ESTIMATED OF TRAVEL TIME BETWEEN GAUGING STATIONS DURING JANUARY 2011**

At Cameron Bridge, the modelled lag time between heavy rain to a rise at the gauge was around 8.5 hours, with a peak around 12.5 hours after the end of the rainfall. The modelled peak travel time between the Mena Park gauge and Cameron Bridge was around 5 hours.

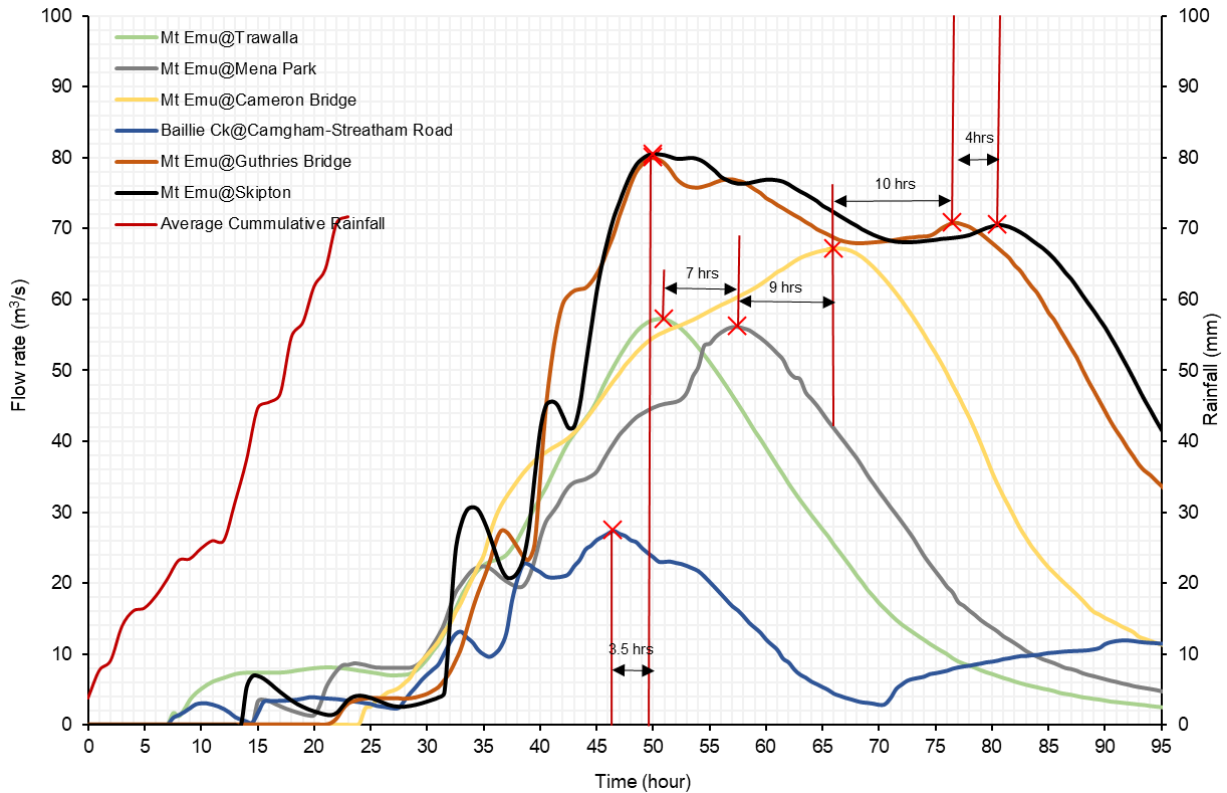
FIGURE A-3 ESTIMATED OF TRAVEL TIME BETWEEN GAUGE STATION IN A 20% AEP EVENT (48-HOUR, TP01)

Hydrographs for the 20% AEP (48 hours) event are displayed in Figure A-3, the time from the start of rainfall to a rise in the Skipton gauge is about 14 hours. The Skipton gauge peaked 27 hours after the end of the rainfall. As shown in Figure A-3, there were two peaks in the Skipton gauge and Guthries Bridge modelled flows. The first peak (i.e. 27 hours after the end of rainfall) was driven by a rise in Baillie Creek at Carngham – Streatham Road bridge, where was peak in 3.5 hours before that recorded at Skipton and Guthries Bridge . After the first peak, flow at Skipton and Guthries Bridge started to fall slowly, but they increased quickly and peaked again at 57.5 hours and 53.5 hours after the end of rainfall. The second peaks at these two gauges were driven by flows in the broader Mt. Emu Creek catchment, with an estimated travel time of 10 to 14 hours from Cameron Bridge.
