Summary Report

Upper Mt. Emu Creek Flood Investigation

Glenelg Hopkins CMA

19 May 2020

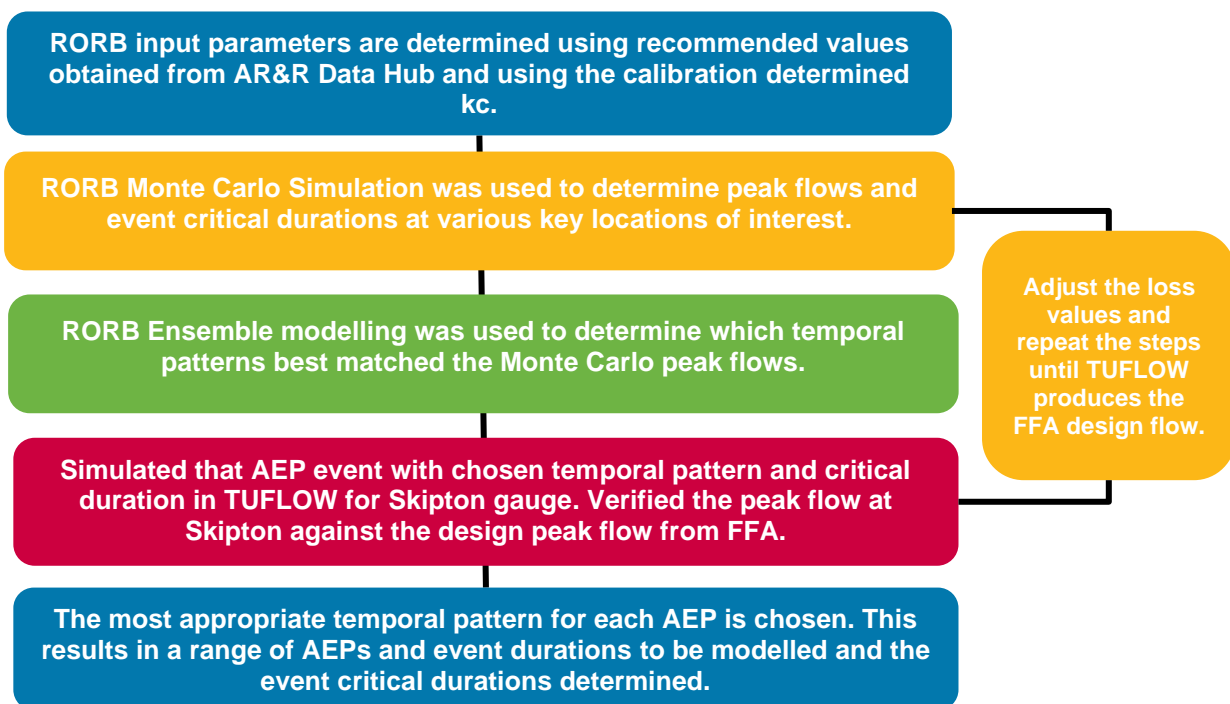
FIGURE 4-1 THE PROCESSES OF HYDROLOGIC AND HYDRAULIC DESIGN MODELLING

The RORB parameters - k_c and m determined in the hydrologic and hydraulic model calibration process were adopted whilst the RORB parameters of rainfall losses were adjusted in a reasonable range until the peak flows at Skipton gauge produced in TUFLOW model matched to the design estimates from the FFA. Figure 4-1 below shows the process of design modelling in RORB and TUFLOW models.

Once the design parameters of RORB model were determined, and the temporal patterns and critical durations were identified at key locations, the design inflows were extracted and input into the TUFLOW model.

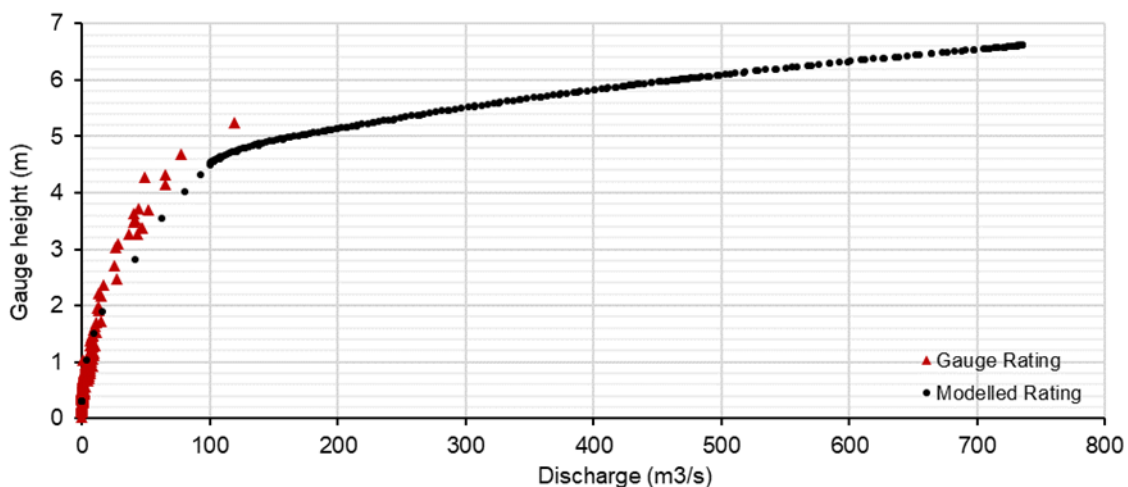
FIGURE 7-1 RATING CURVE COMPARISON AT SKIPTON GAUGE

- Gauge Rating Curve Estimates
 - Comparisons between the existing and modelled rating curve was made. Information on low flows was missing in the modelled rating curves given only relatively high flow events were modelled. The modelled rating curves are expected to perform much more accurately high flow when the total flow is dominated by floodplain flow. An example rating curve comparison at Skipton is shown in Figure 7-1.

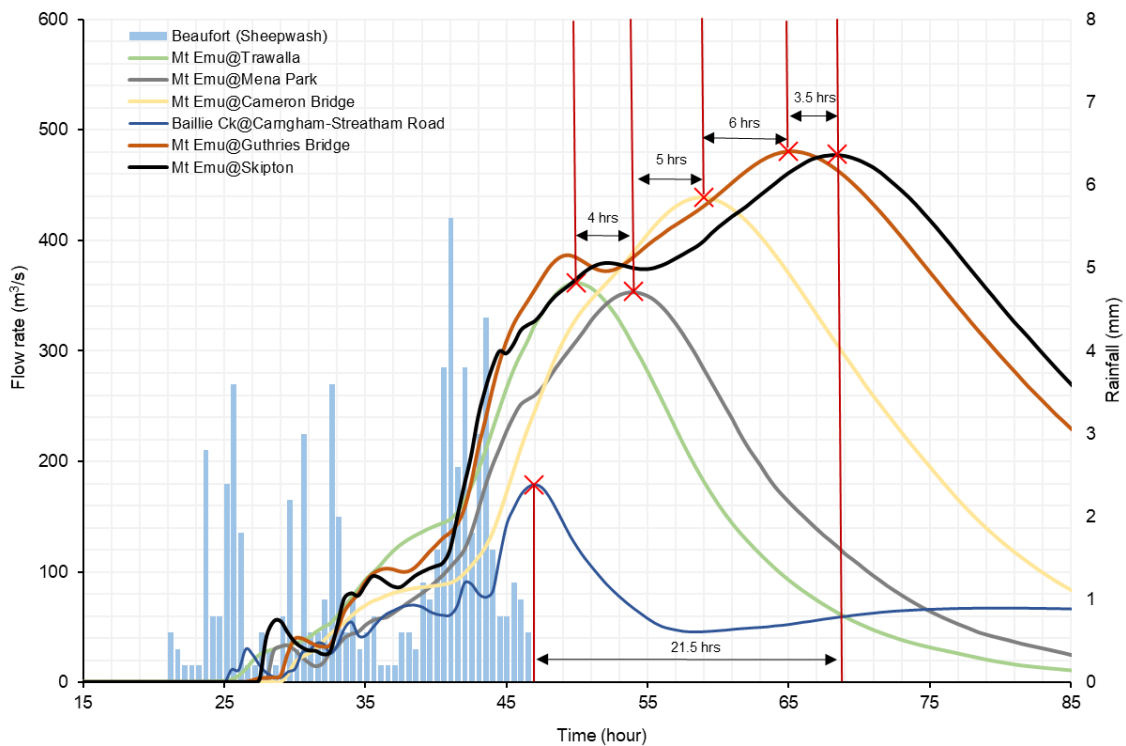
FIGURE 7-2 TRAVEL TIME ESTIMATES FOR JANUARY 2011 FLOOD

- The effective warning time along the Mt. Emu Creek and Baillie Creek varies between flood events, depending on the storm durations, the magnitude of the event and catchment antecedent conditions. The travel time from the Mena Park gauge to Camerons Bridge is generally between 5 to 9 hours. The travel time from upstream gauges along Mt. Emu Creek and Baillie Creek to the Skipton gauge and Guthries Bridge gauge varied depending on which waterway dominated flow. From a flood warning perspective, Guthries Bridge can confirm the expected forecast at Skipton and should be used as a key site supporting flood forecasting. The travel time from Guthries Bridge gauge to Skipton gauge was between 2 to 4 hours. An example of travel time for the January 2011 flood is shown below.
