Upper Avoca River Flood Investigation

Data Review Report

001 | RevB

Pyrenees Shire Council

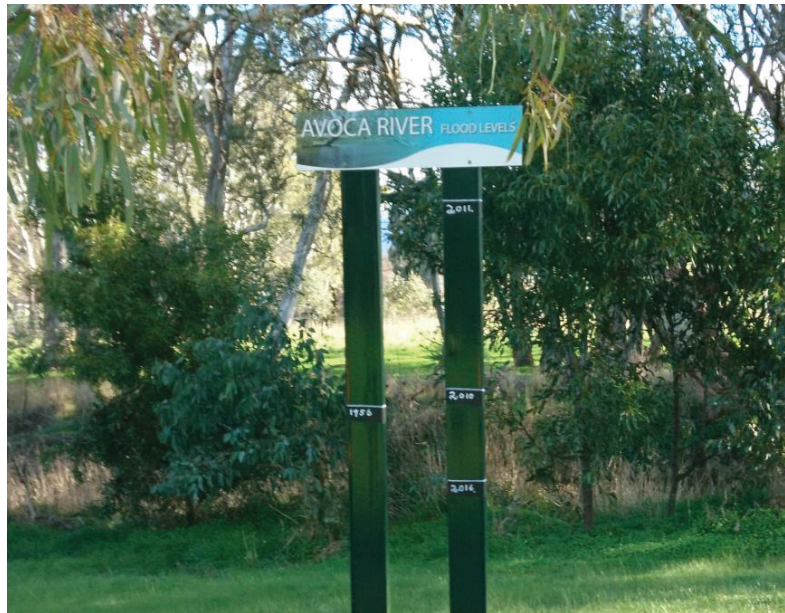
Figure 2.1: Avoca Flood Pole

During the site visit (refer to Section 2.9) Jacobs also identified the Avoca community flood pole (Figure 2.1) located at the corner of Dundas Street and North Street identifying 1956, 2010, 2011 and 2016 flood levels.

- The surveyed flood level marks were used for calibration and validation of the flood model
- Field survey of the additional flood level marks at the Avoca Flood Pole was captured
- The historic flood information (pre-recorded stream gauge data) is used as historic flood event inputs into the at-site flood frequency analysis
